Department of State Growth
 Perth Link Roads

Landslide Hazard Bands
 Preliminary Design

Perth Links Project

ASSESSMENT OF POTENTIAL IMPACT ON ECOLOGICAL VALUES OF PROPOSED PERTH LINKS AND ASSOCIATED CONNECTORS, TASMANIA

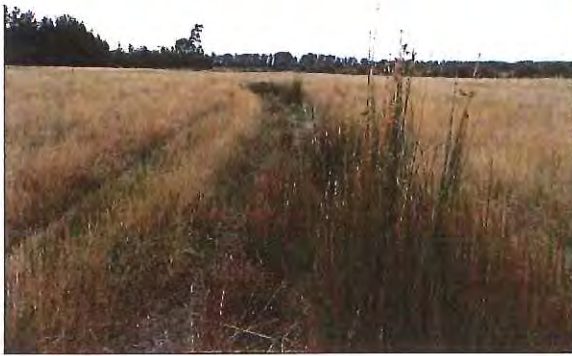
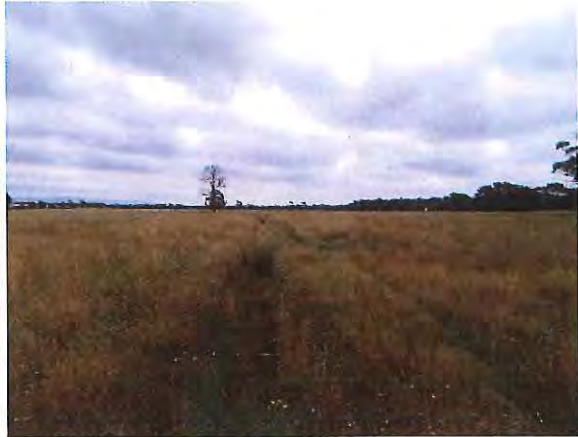
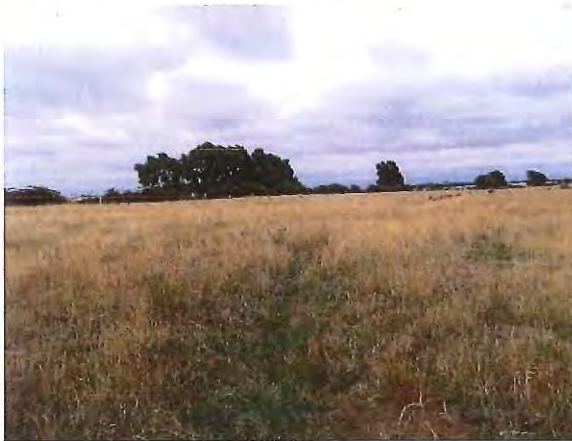
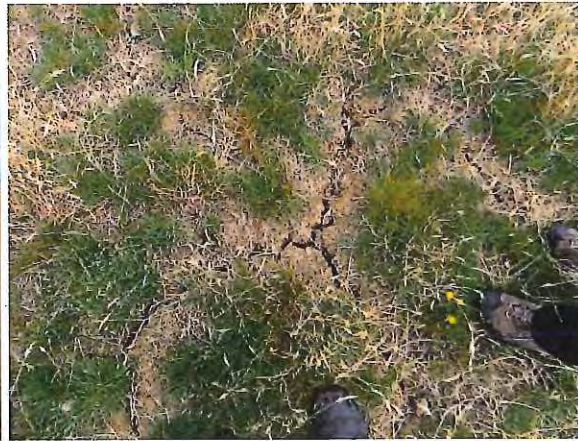
Views of drainage depressions in pasture between Illawarra Road and Western Line (note the image of cracked clay soils) (15 Feb. 2017)

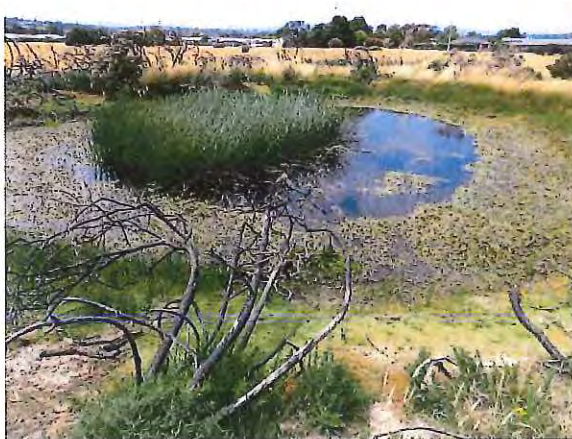
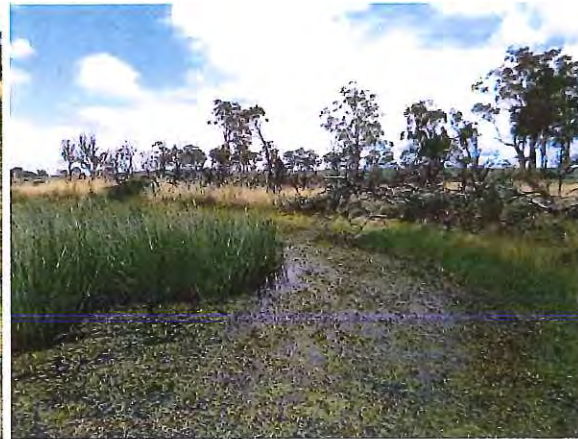
Views of "gorse paddock dam" (15 Feb. 2017)

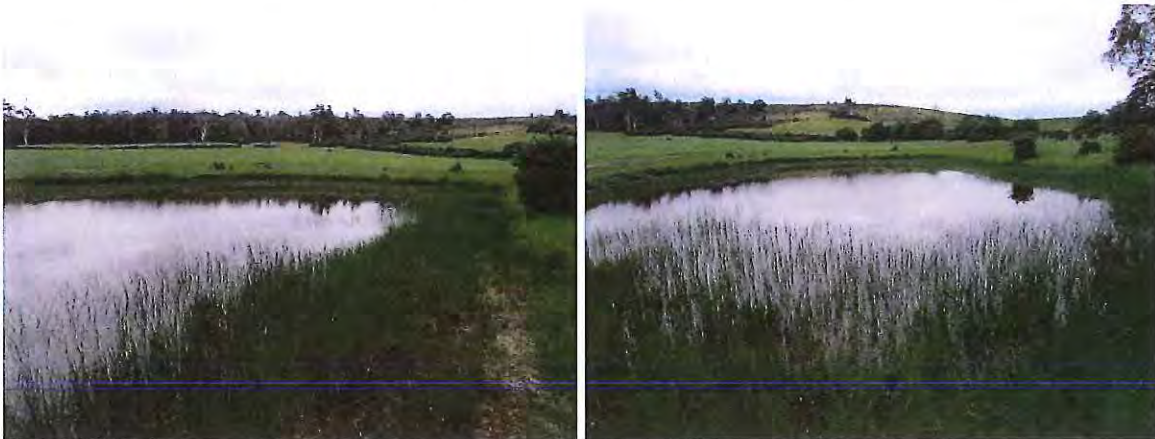
Views of Sheepwash Corner dam (20 Nov. 2014) – note the substantial change in condition between 2014 and 2017

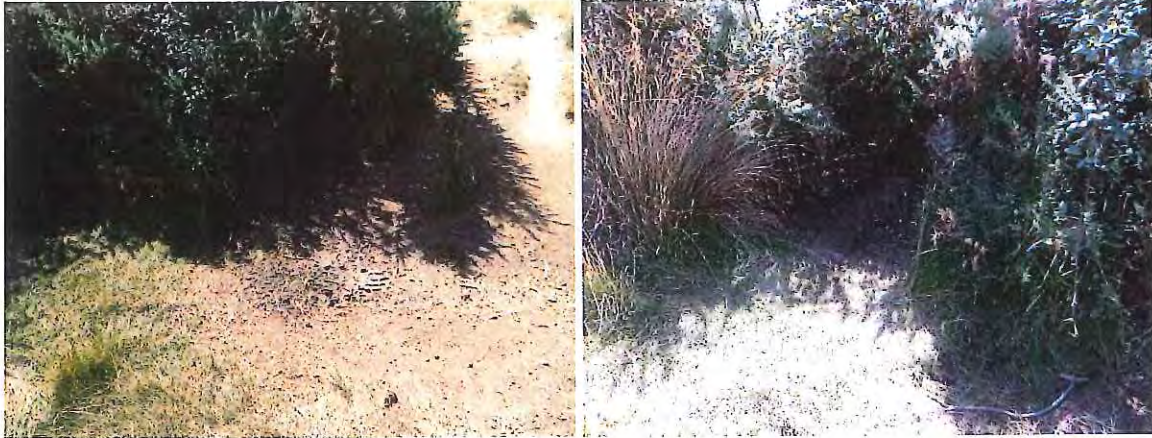
Views of Sheepwash Corner Creek (15 Feb. 2017) – note the stock access

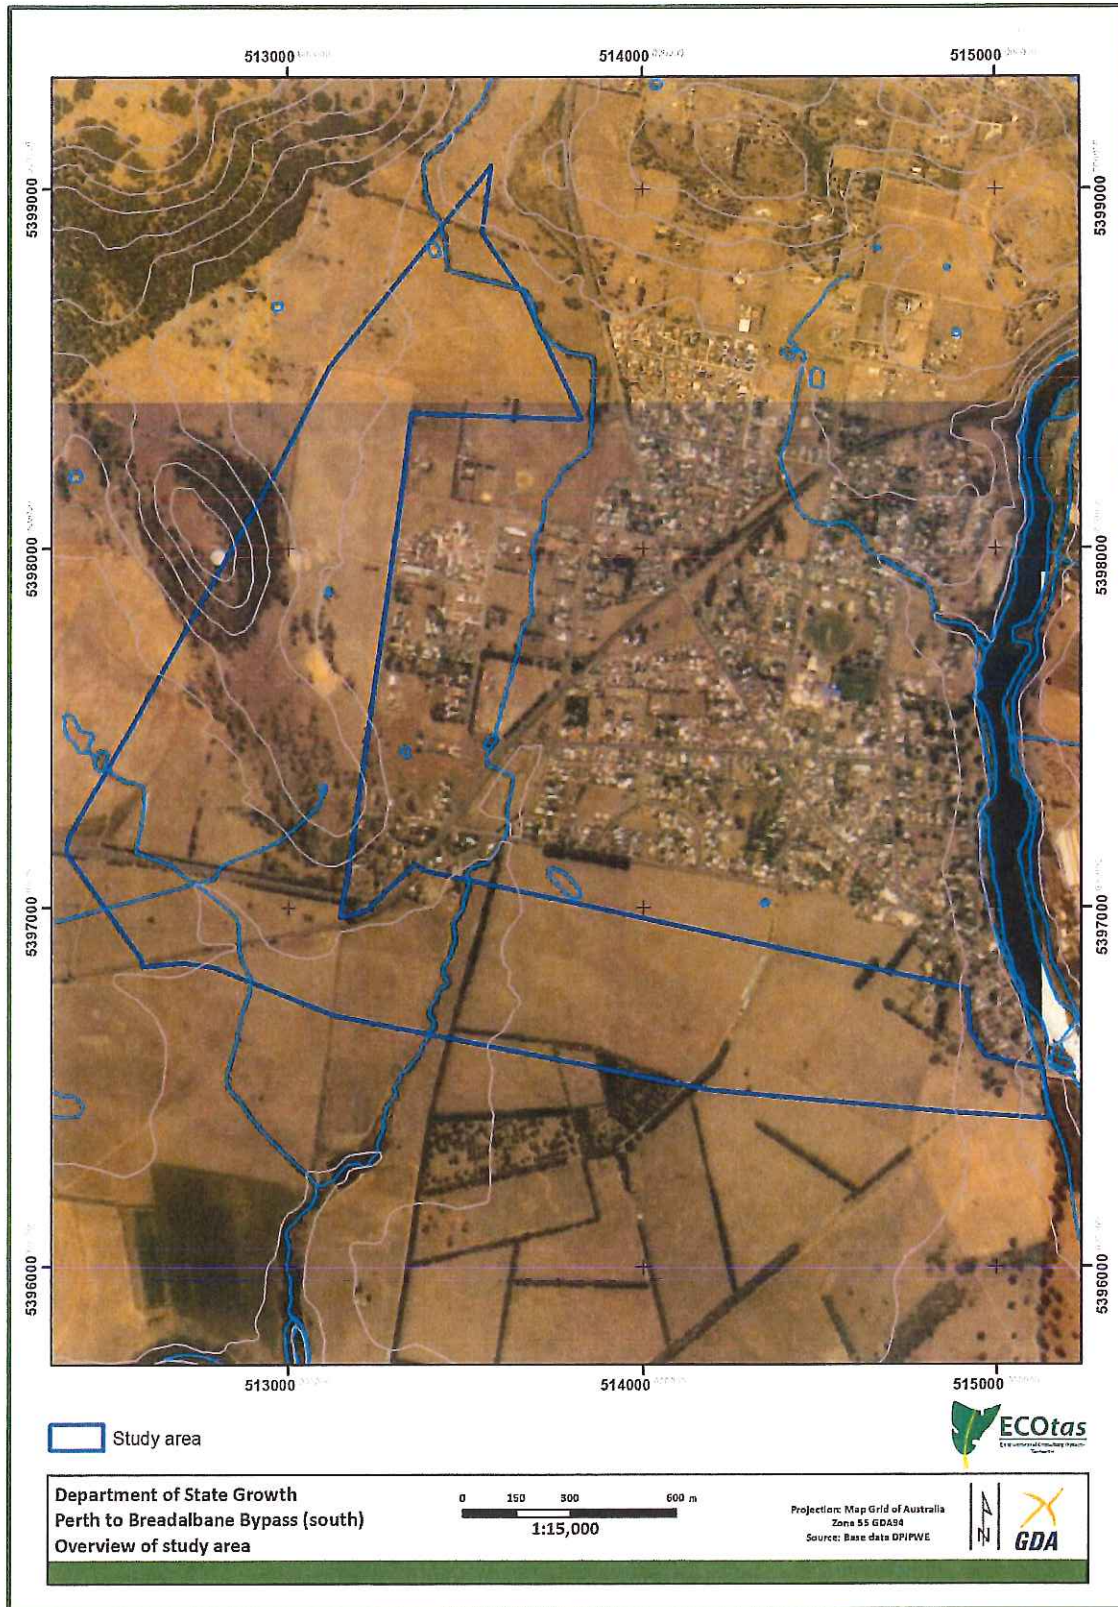
Figure 2. Current land use and vegetation condition of study area
