Cressy Swimming Pool Master Plan
Northern Midlands Council

INTRODUCTION

NORTHERN MIDLANDS COUNCIL - CRESSY SWIMMING POOL – CONDITION ASSESSMENT

Ross Swimming Pool Master Plan
Northern Midlands Council

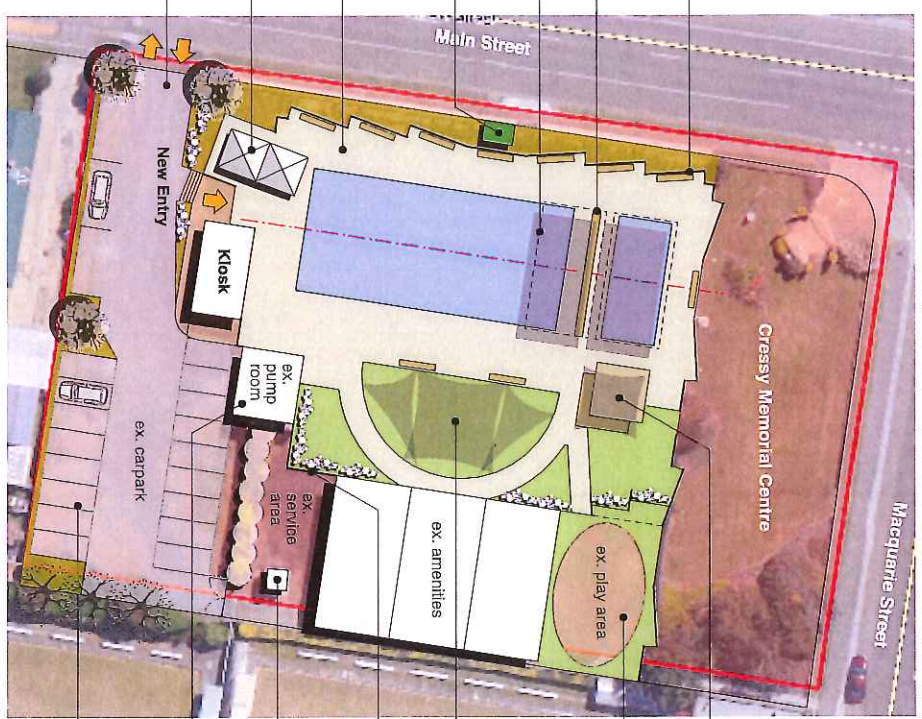
- Perimeter Fencing:**
Combination of solid / transparent panels to provide wind protection and visual connection to street, Memorial Centre & distant views.
- Pool Cover:**
New pool cover enclosure to double as seating
- New Shade Structures:**
Permanent cantilevered skillion shade structures over toddler & main pools
- New Bus Shelter:**
New bus shelter structure representing upgraded building style of the pool complex
- Pool Concourses:**
New paving / tiling to pool surround, repair ex. conc. substrate as req'd.
- New Entry / Seating Area:**
Relocate entry to street side, upgrade existing kiosk building & provide new seating area with transparent glazed barrier to street & shade structures over.
- Upgrade Entry / Pool Signage:**
New signage element & landscape treatment to frontage

- New Sundeck:**
Provide new elevated timber sundeck with built in pool cover enclosure & step seat. Shade structure over.
- Playground:**
Provide new safety fencing to playground. Upgrade softfall surface as req'd
- New Shade Structures:**
Provide new shade structures over central grassed area.
- Internal Screen:**
New slatted timber privacy screen to conceal ex. service area
- Water Treatment:**
Upgrade chlorination treatment system as per Pool Consultant recommendations.
- Ex. Pump Room:**
Make good roof & wall treatment / finishes to match remodelled Kiosk Area.
- Carpark:**
Reconfigure & re-surface existing carpark area as shown.

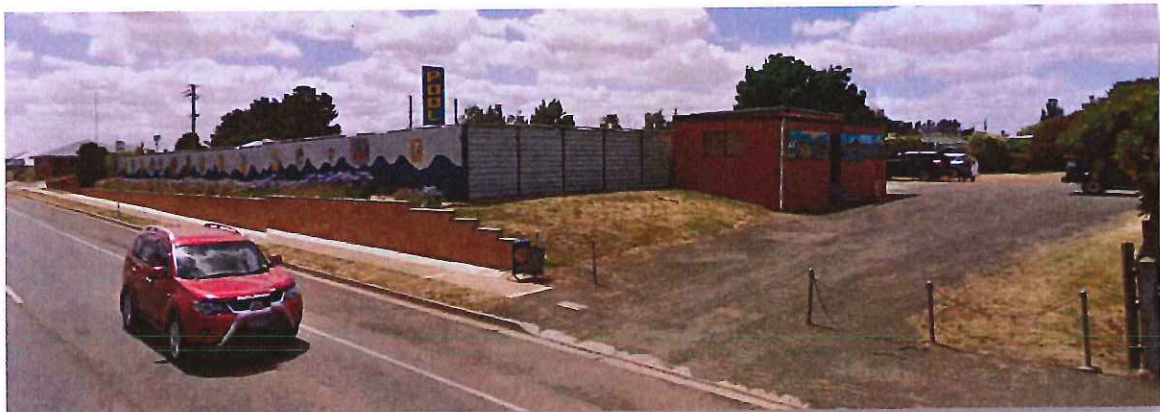
Figure 2 – Existing access and parking from Main Street

Vehicular access is currently located upon the southern boundary. Off-street parking appears to address current needs but is in need of resurfacing and identification to maximise capacity.

Relocation of the main pool entrance to the street frontage would afford opportunities to provide a prominent and celebrated access point to the facility in addition to improvement of operational and security issues. Appropriately designed surfaces, fencing and landscaping should respond to the streetscape and capitalise on views to and from the site.

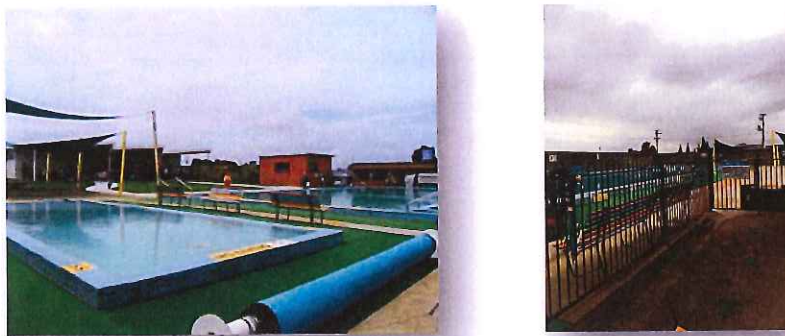
Figure 4 – Pool capping and concourse require upgrading to safer options.

The overall structural condition and hydraulic integrity of the pools also appear to be adequate and fit for purpose, subject to detailed improvement of the pool concourse in addition to additional shading. Application of new concourse paving material, in conjunction with appropriate signage / surface treatment, would increase pedestrian safety around the pool areas.

2. Pool concourse & fencing – Opportunities to minimise OHS issues, gain access to views and increase visual connection to the streetscape and Memorial Park beyond.

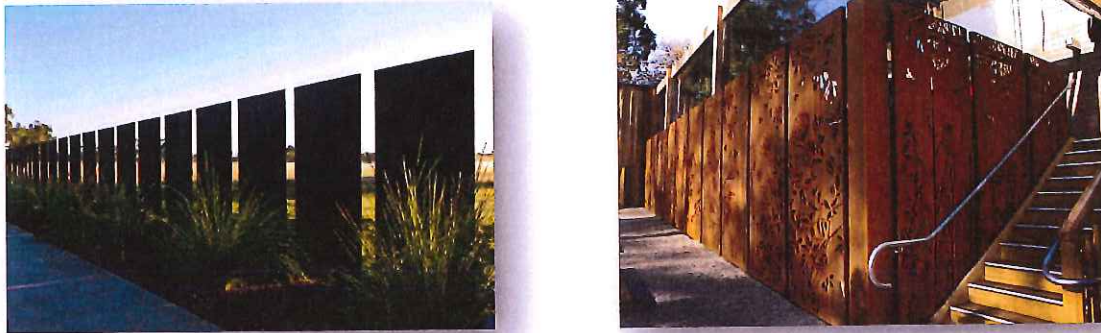
Figure 5 – Potential fencing options may include gaps, cut-outs or transparent infill to capitalise upon views whilst maintaining privacy.

The current pool facility is also visually separated from Main Street and adjacent Memorial Park which would benefit from appropriately designed barriers / fencing that facilitated valuable visual links to the pool from these areas via transparent sections and/or appropriate articulation of solid panels.

Appropriately designed screening would afford opportunities to capitalise on the views at hand whilst assisting with privacy to and from the site.

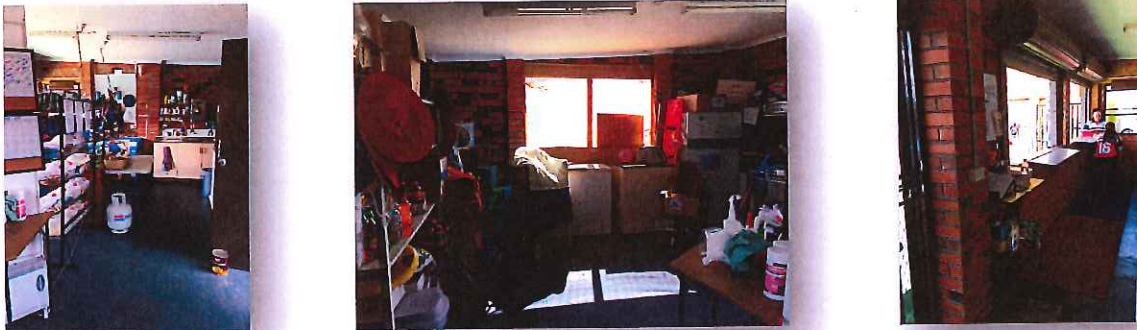
Figure 8 – Existing amenities are outdated and currently used for storage of most maintenance and safety equipment.

The existing Kiosk facilities are out-dated and suffer from a general lack of space, with particular attention drawn to storage and inadequate Kiosk area. Redevelopment of the existing Kiosk space would afford improved storage in addition to separate Office / Store for non-retail items, i.e. first aid / safety equipment.

1. Redevelopment of Kiosk / Entry – Considered a high priority due to lack of storage space and opportunities for improved street address of the pool facility.

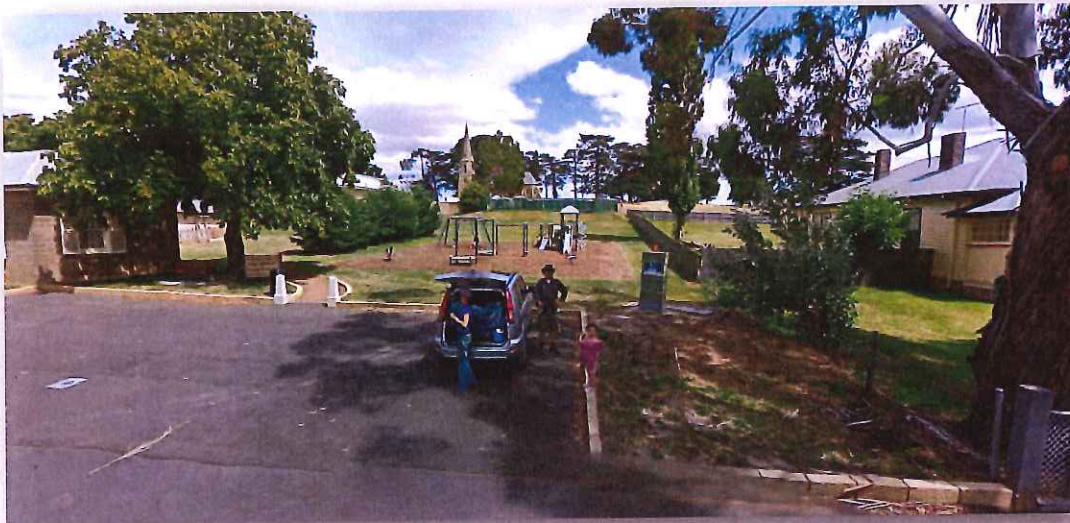
Figure 3 – Existing pedestrian access and parking from Bridge Street

Whilst the Ross Swimming Pool is centrally located within the township, pedestrian and vehicular access is not readily obvious to non-local visitors. Pedestrian access from Bridge Street is via a gravel path extending from the existing carpark adjacent the playground area, which continues past the rear boundaries of Church Street properties and some existing vegetation of questionable value.

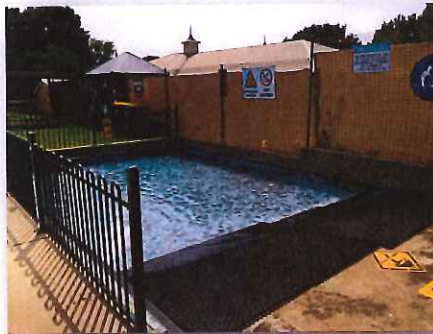
Figure 6 – Toddler pool surfaces, balustrades and pool concourse require upgrading to safer options.

- Toddler pool fencing and tiled lining requires upgrading / replacement.
- The above-ground pool covers are considered adequate and are only used seasonally.

The overall structural condition and hydraulic integrity of the pools also appear to be adequate and fit for purpose, subject to some detailed improvement of the pool concourse in addition to toddler pool lining and barriers. Existing signage located upon the current surface is reported to be slippery when wet and poses potential safety issues. Application of new concourse paving material, in conjunction with appropriate signage / surface treatment, would facilitate increased safety to the pool surrounds.

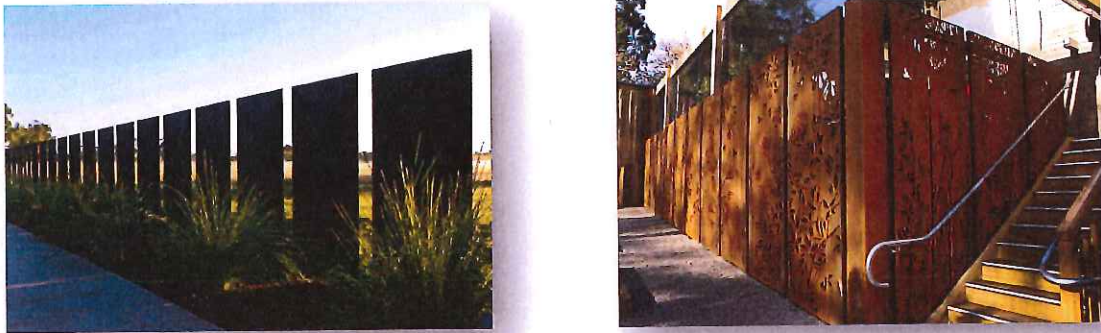
Figure 7 – Potential fencing options may include gaps, cut-outs or transparent infill to capitalise upon views whilst maintaining privacy.

The current pool area is also visually separated from the adjacent playground which would benefit from appropriately designed barriers / fencing that allowed parents to adequately monitor children using the play equipment in addition to creation of valuable visual links to the pool from Bridge Street.

Improved external barriers / fencing would also provide opportunities to protect the pool concourse from prevailing North Westerly winds, exacerbated by the subject site's elevation. Appropriately designed screening would afford opportunities to capitalise on the views at hand whilst assisting with privacy to and from the site.

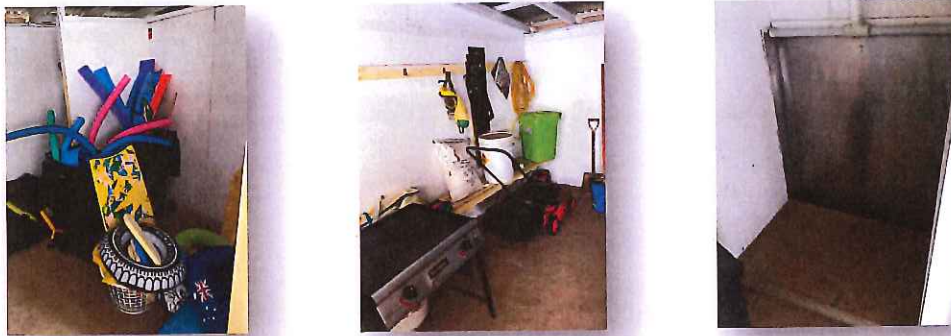
Figure 8 – Existing amenities are outdated and currently used for storage of most maintenance and safety equipment.

The existing facilities are generally out-dated and suffer from a general lack of space, with particular attention drawn to equipment storage and inadequate kiosk area. It is anticipated that the existing footprint of the Changeroom building may be adequate for incorporation of contemporary amenities on the premise that suitable storage for ancillary equipment be provided elsewhere on site.

The Kiosk / Entry area, currently undersized, would be able to accommodate storage of less bulky essential equipment, i.e. first aid supplies, Lifeguard apparel / equipment in addition to general Kiosk provisions if redeveloped appropriately.
