**Response to the Geo-Environmental  
Solutions Initial Review of the  
Agricultural Assessment for the  
Ridgeside Lane Development**

This report has been undertaken on behalf of the proponent (Traders In Purple) in response to the Geo-Environmental Solutions (GES) initial review of the agricultural report for the Ridgeside Lane development on the Queenscliff and The Mews properties.

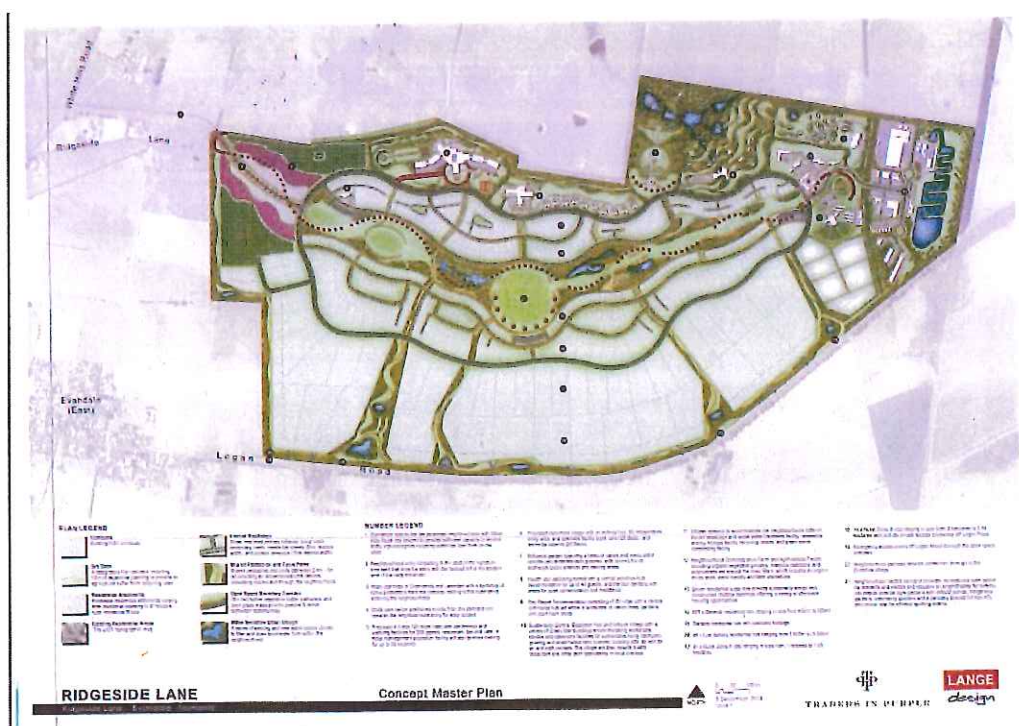
Figure 1: Master Plan Ridgeside Lane (Lange Design)

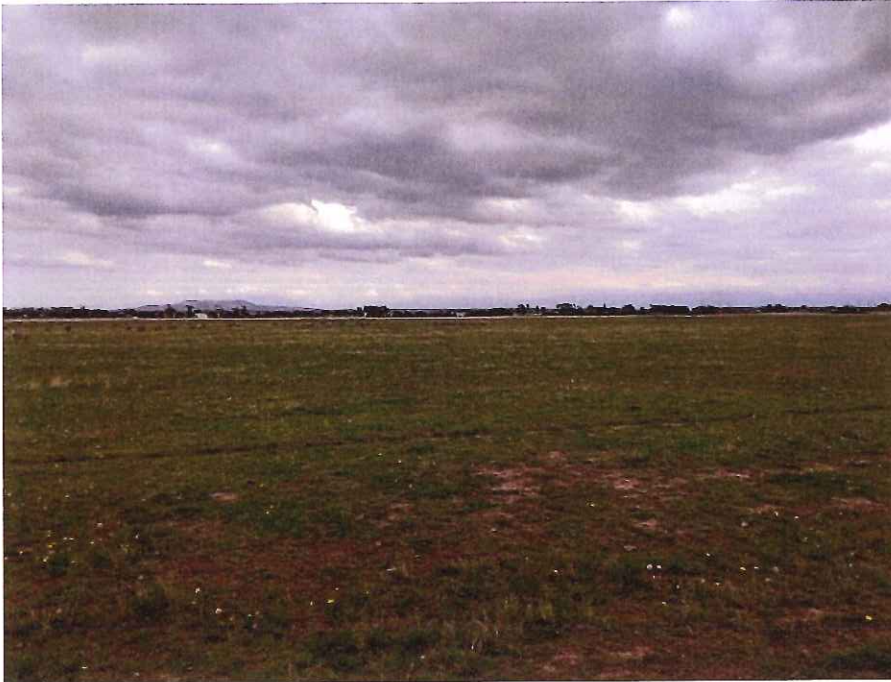
*Figure 3: Grazing Land within the Site*

The subject land is currently grazing land.

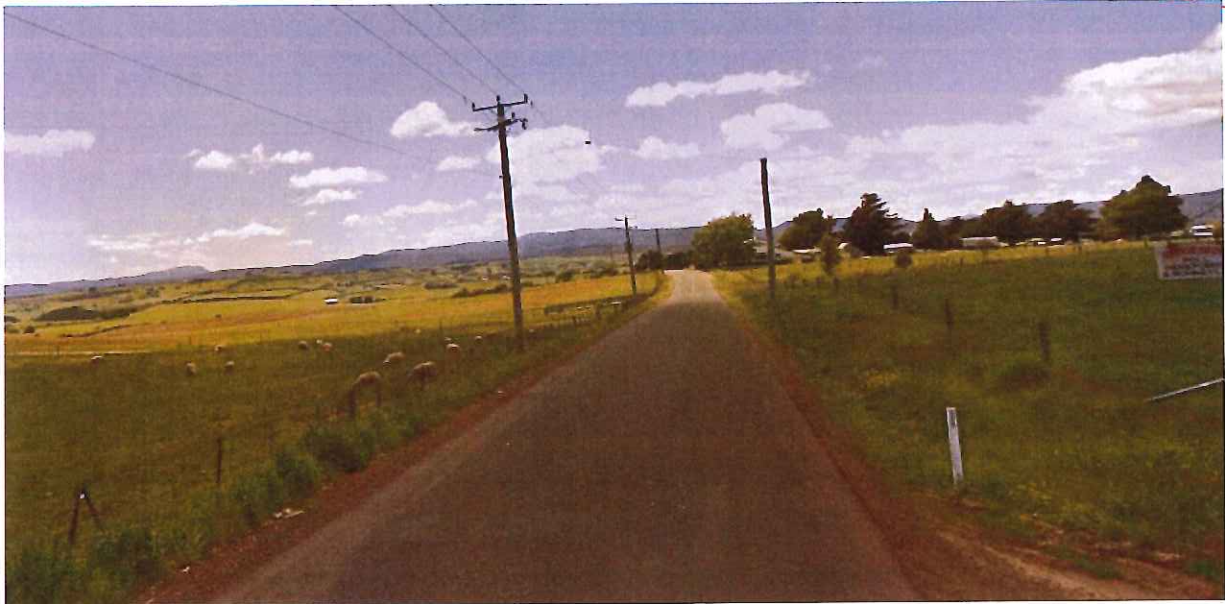
Figure 6: Ridgeside Lane - Access to the Site

In the original design only one access point into a site presented a real Bushfire risk. A single access point restricts choice of escape during a Bushfire; it limits access for fire fighting equipment when tackling fires. The design has been amended to show emergency access points to Logan Road. As such the public and fire fighting access is now compliant.

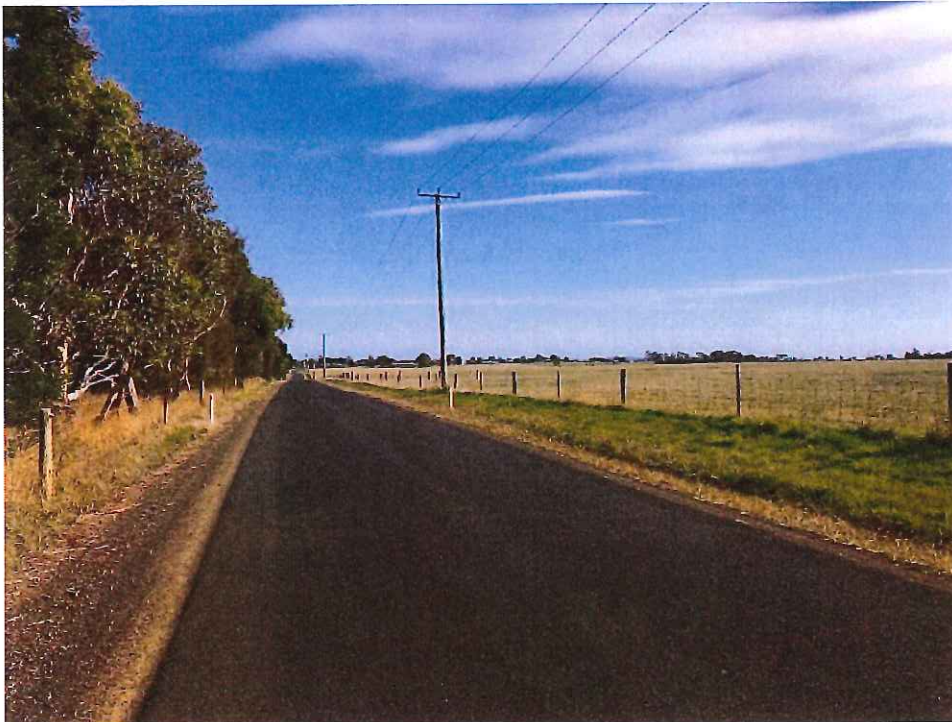
Figure 7: Logan Road - Where Emergency Access to the Site is Proposed

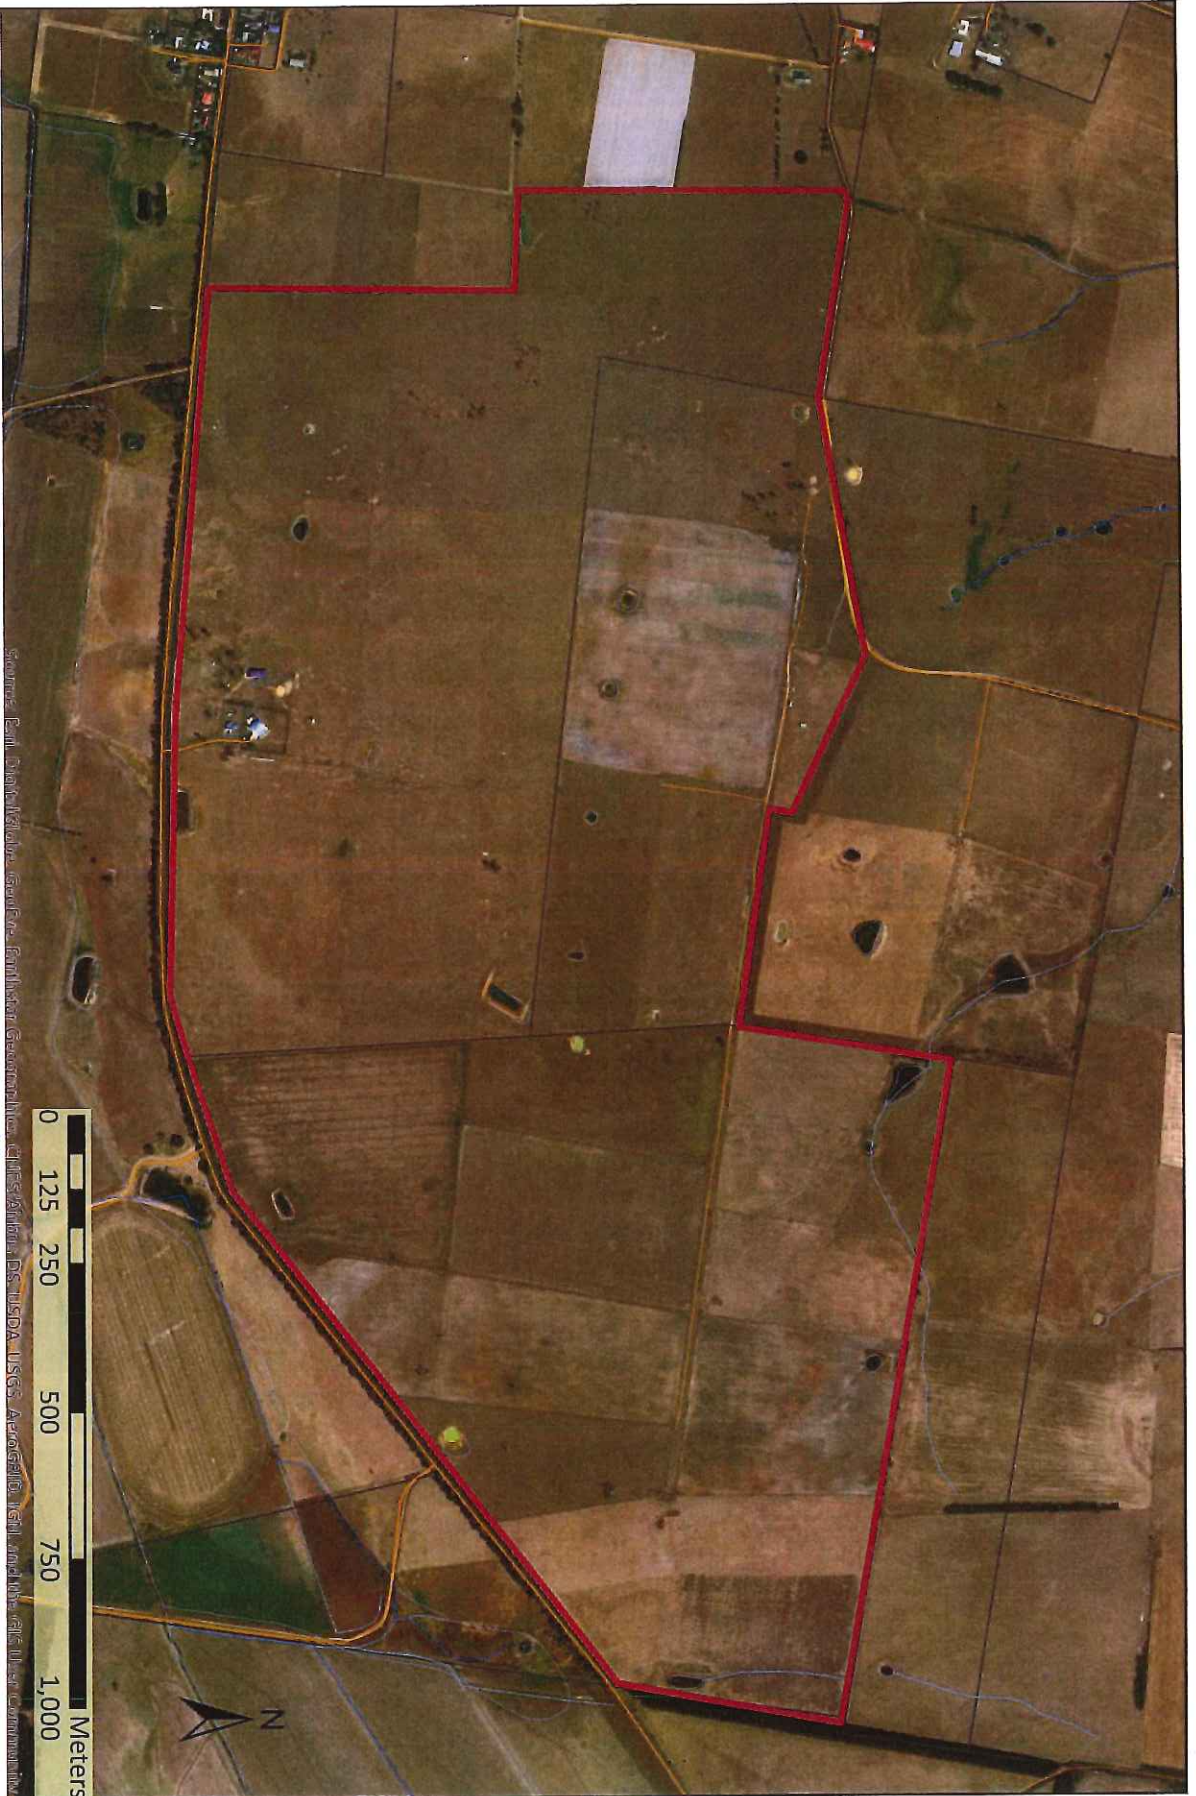
Figure 1. The Evandale property proposed for development by Traders in Purple with the boundary shown in red.

A satellite image of the property is shown in Figure 1. while Figure 2 shows the property boundary, waterbodies and position of mapped vegetation types

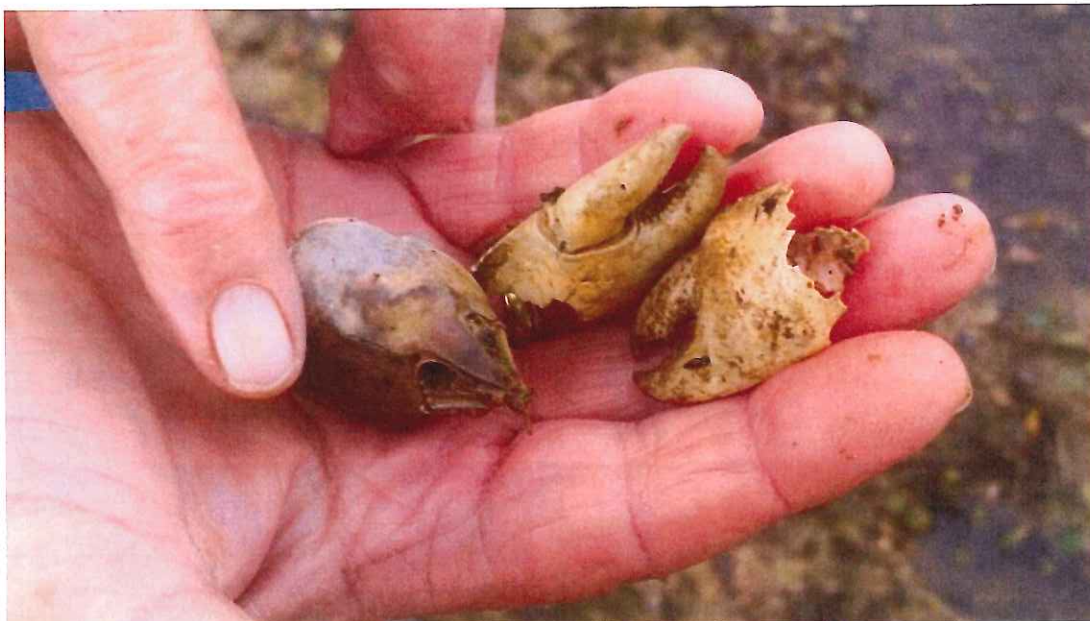
Figure 3. Carapace and claws of the pest species the yabby found in dams in proximity to the residence.

There were claws and carapaces of the introduced pest species, the yabby (*Cherax destructor*) found beside a two of the dams near the residence, indicating a population of this species is present (Figure 3). Active burrows were seen within these dams. A map showing waterbodies with good habitat suitable for Green and gold frogs is shown in Figure 4 and also includes the two dams where yabbies were present.

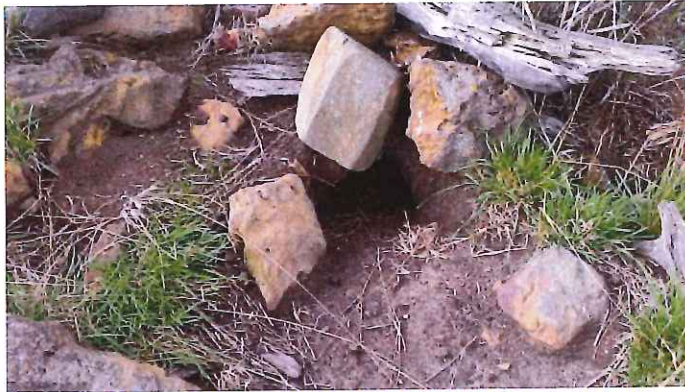
Figure 5. Piled material, providing refuge for native mammals, in this case wombat

The areas of remnant woodland trees were inspected and there were potential habitat opportunities in a few trees for native fauna, such as in trees containing hollows in the trunk and under the roots. A possum was found in one of the tree hollows and there was wombat (*Vombatus ursinus*), pademelon (*Thylogale billardierii*) and possum (*Trichosurus vulpecula*) sign seen in other areas. Some diggings were found that looked to be consistent with the Eastern Barred bandicoot (*Perameles gunnii*) in a two areas in close proximity to cover from windbreaks or remaining copses of gorse. There were also a few places where there were tree roots, piles of logs or of gorse for instance that would provide some refuge for other native and introduced fauna (Figure 5). Large hollows in a few of the remaining paddock trees may provide nesting and roosting habitat for the endangered Tasmanian masked owl (Figure 6) (TSPA and EPBCA).

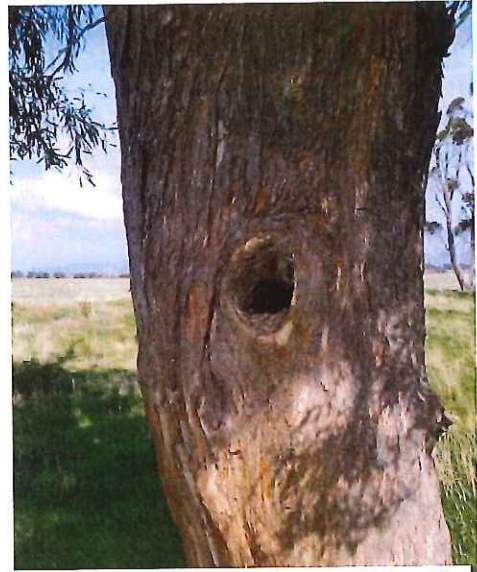
Figure 6. Tree hollow providing potential nesting opportunity for masked owl
