PLANNING APPLICATION PLN-21-0020

77-79 MAIN STREET, CRESSY

VISITOR ACCOMMODATION & SUBDIVISION (2 LOTS) 4/3/21
.....
.....
.....

The attached UPSS Decommissioning Report shows the decontamination process of a former service station located at 77-79 Main Road Cressy. The results were compared with NEPM guidelines and found the level of risk to be acceptable for Residential Development. The report shows that the planning requirements have been met.

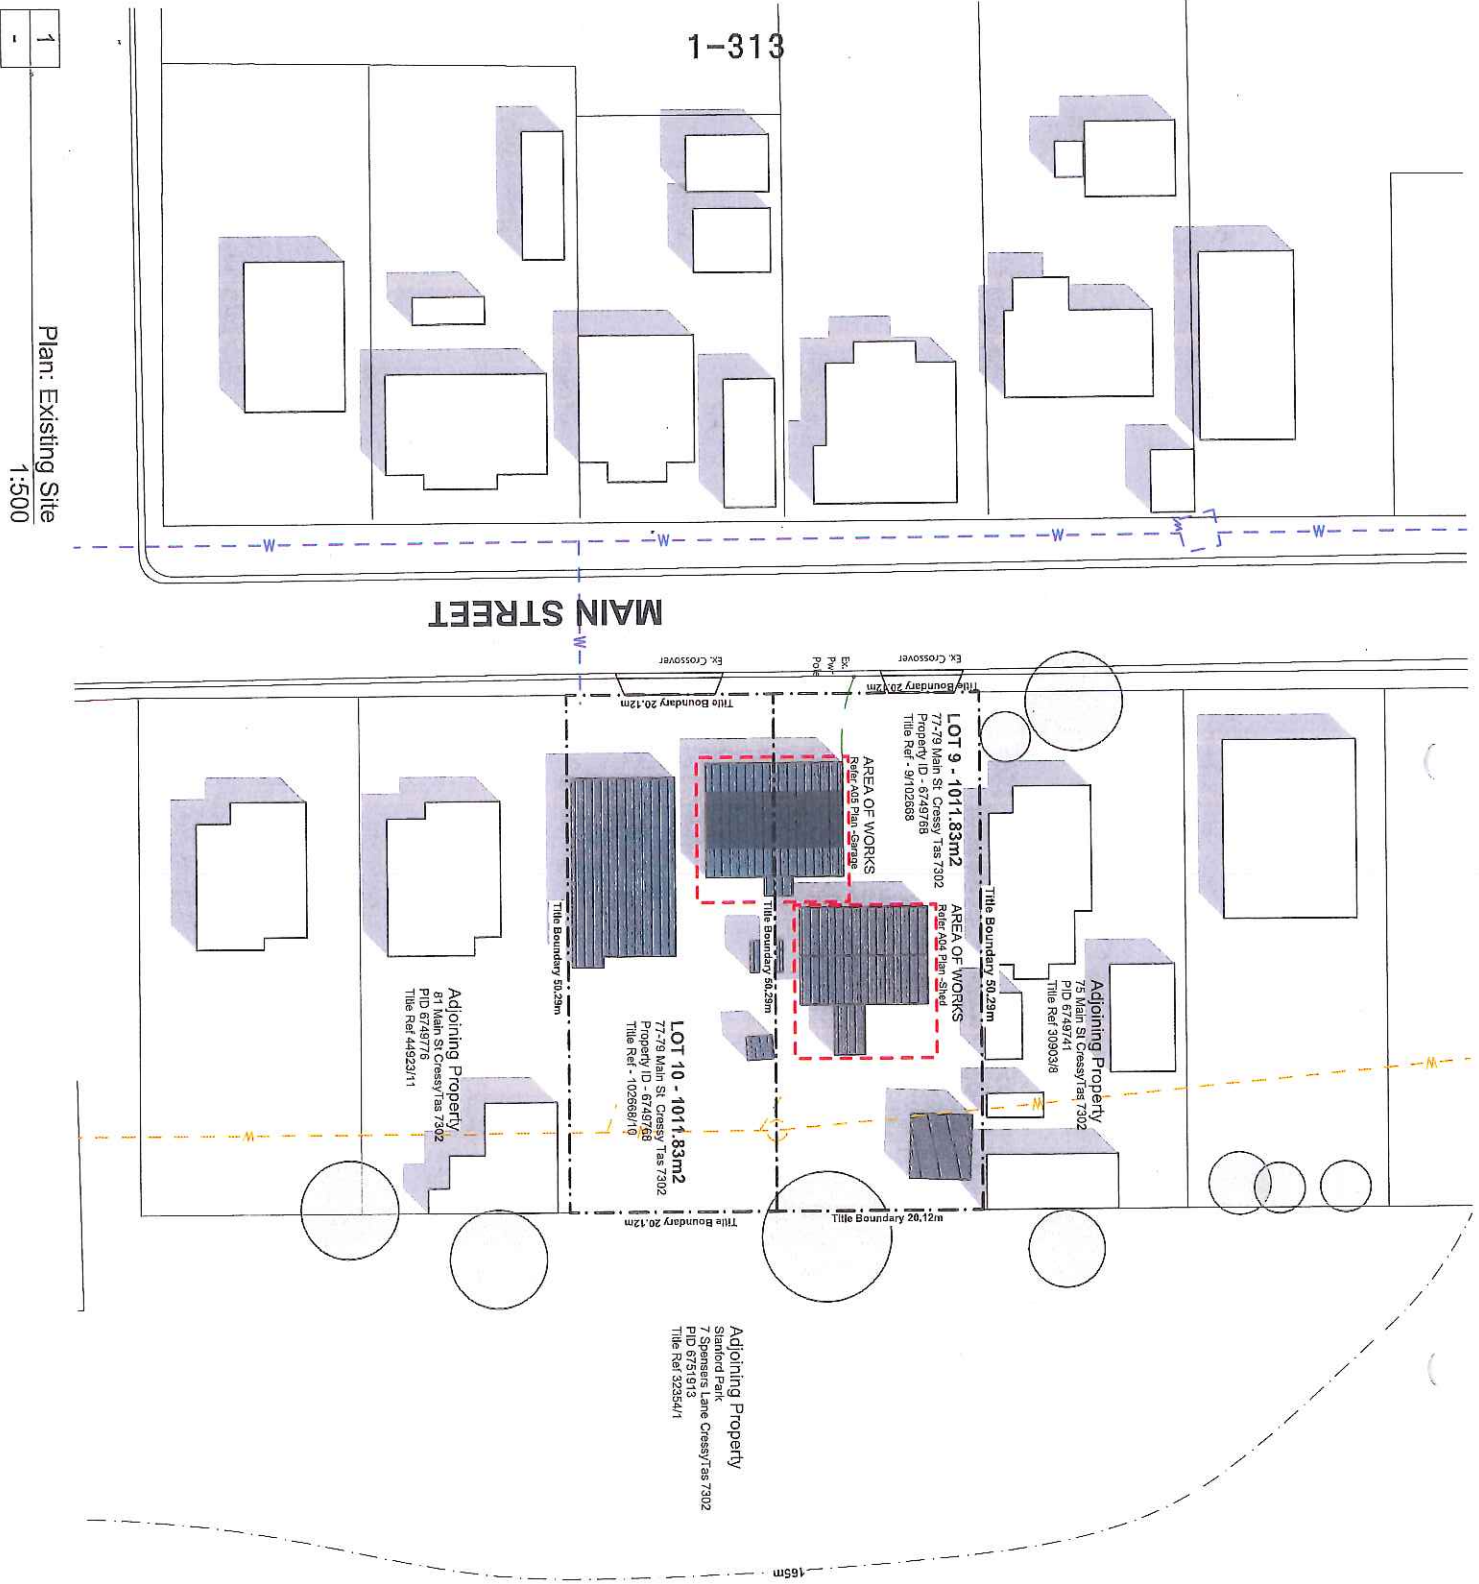
Boundary & Building Location

The Boundary is Approx only.
 A Land Surveyor is to be engaged prior to construction to accurately locate the boundary and fencing.

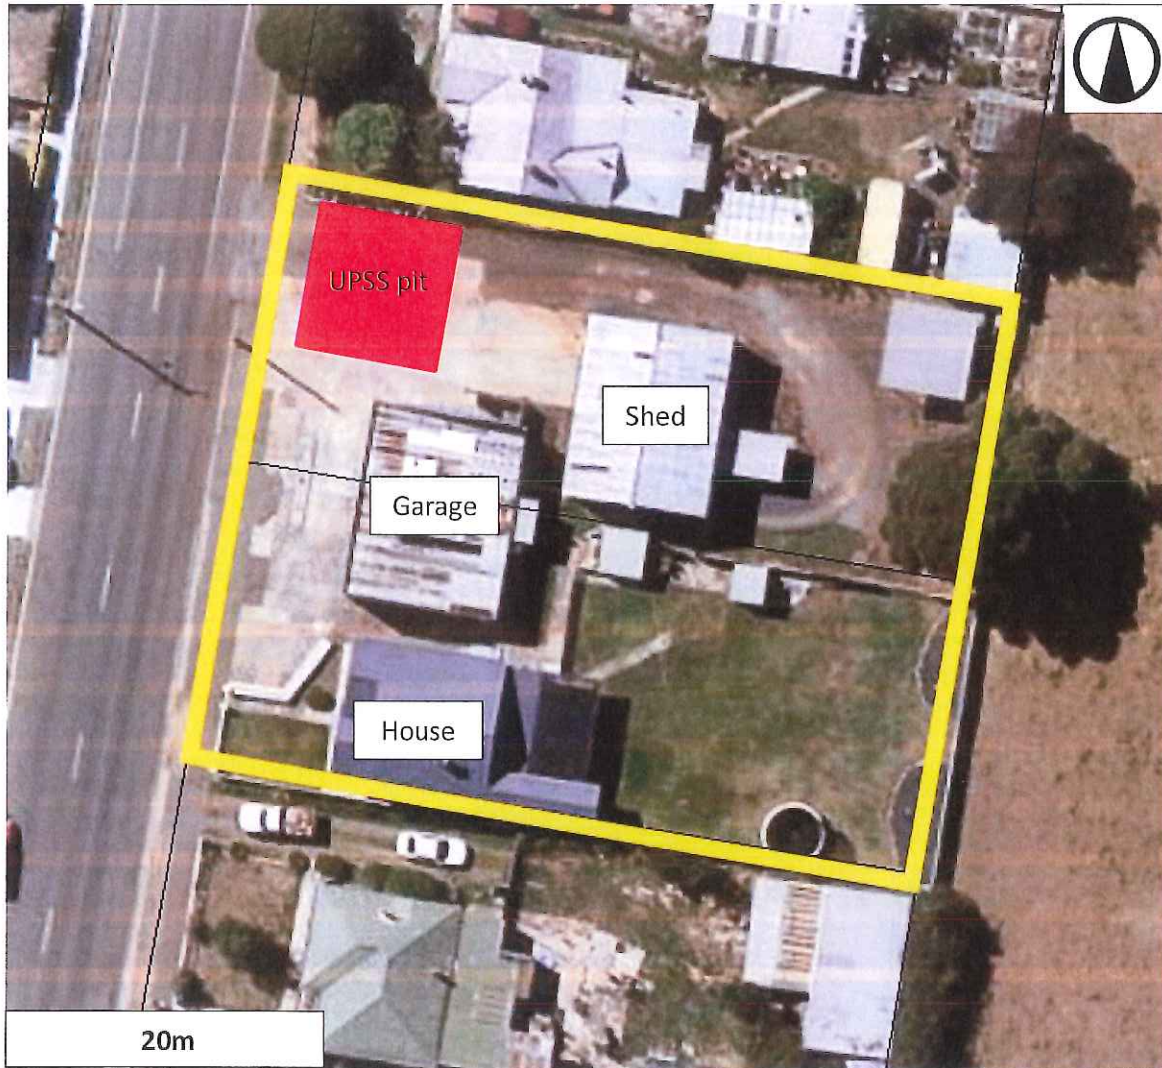
Figure 1: Site Plan

A site plan is given in Figure 1.

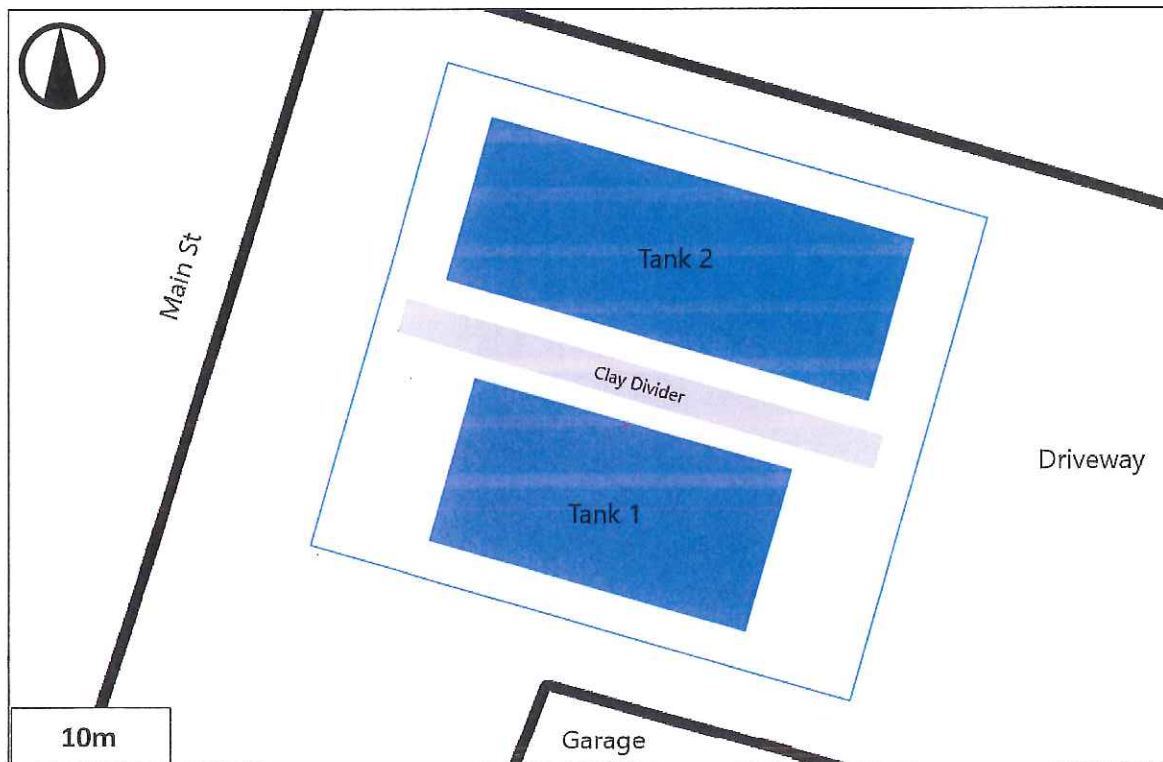
Figure 6: UPSS Detail

<i>Tank</i>	<i>Installed</i>	<i>Contents</i>	<i>Capacity (L)</i>	<i>Construction</i>
1	Unknown	ULP	5,000	6mL steel
2	Unknown	ULP	10,000	8-10mL steel

Figure 6 shows the layout of the tank pit.

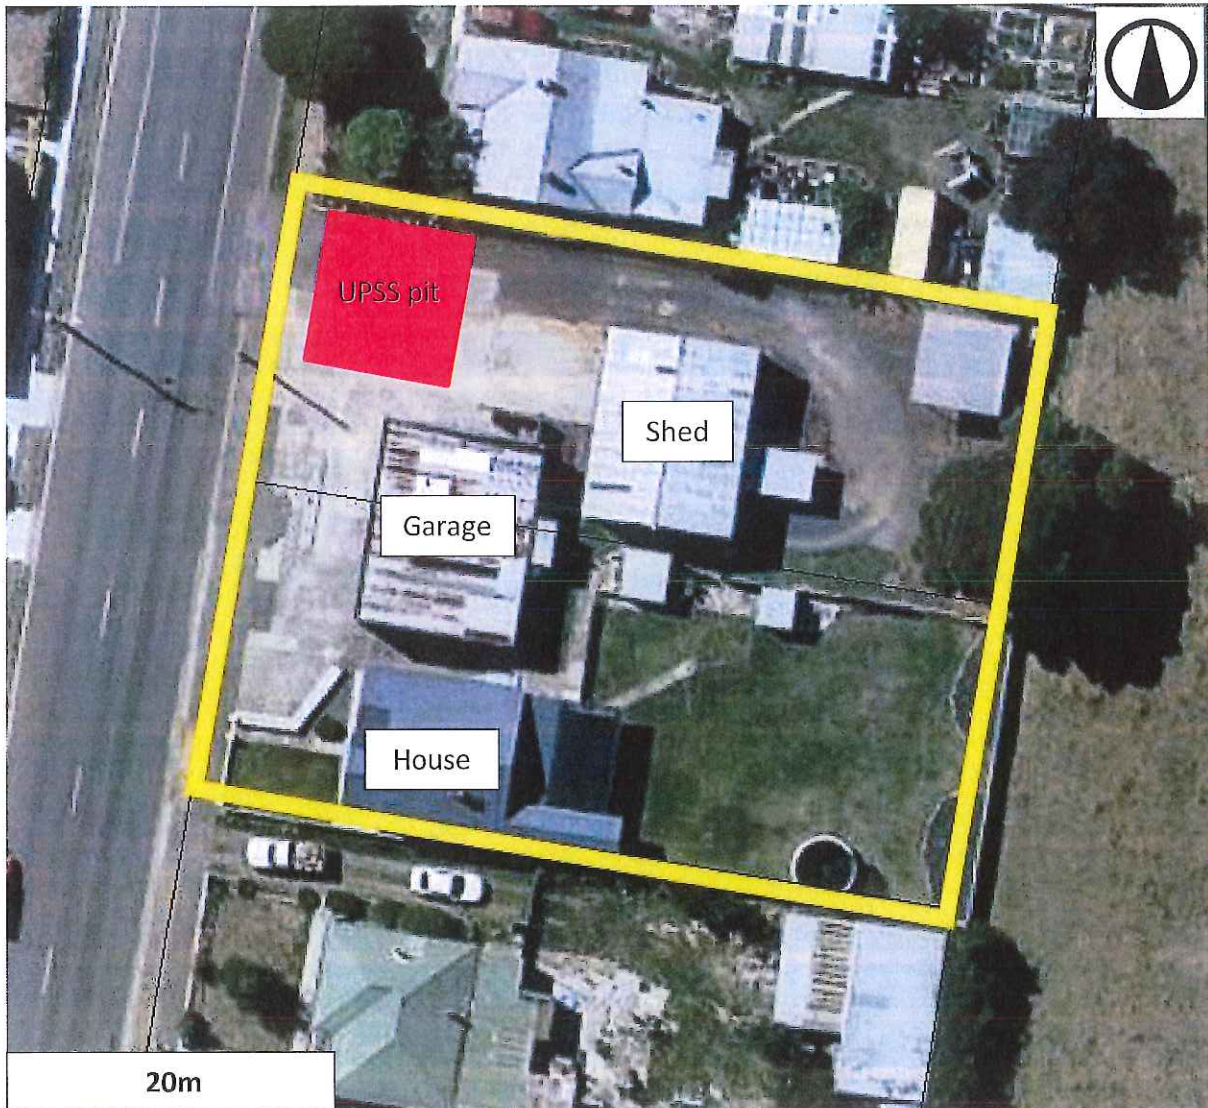
Figure 2: Site Plan

Refer to Figure 1 (Site Plan).

The UPSS consisted of two tanks in a single pit divided by a clay wall, located in the northwest corner of the site, see Figure 1 for pit location and Table 3 for details. Bowsers and lines were not located.

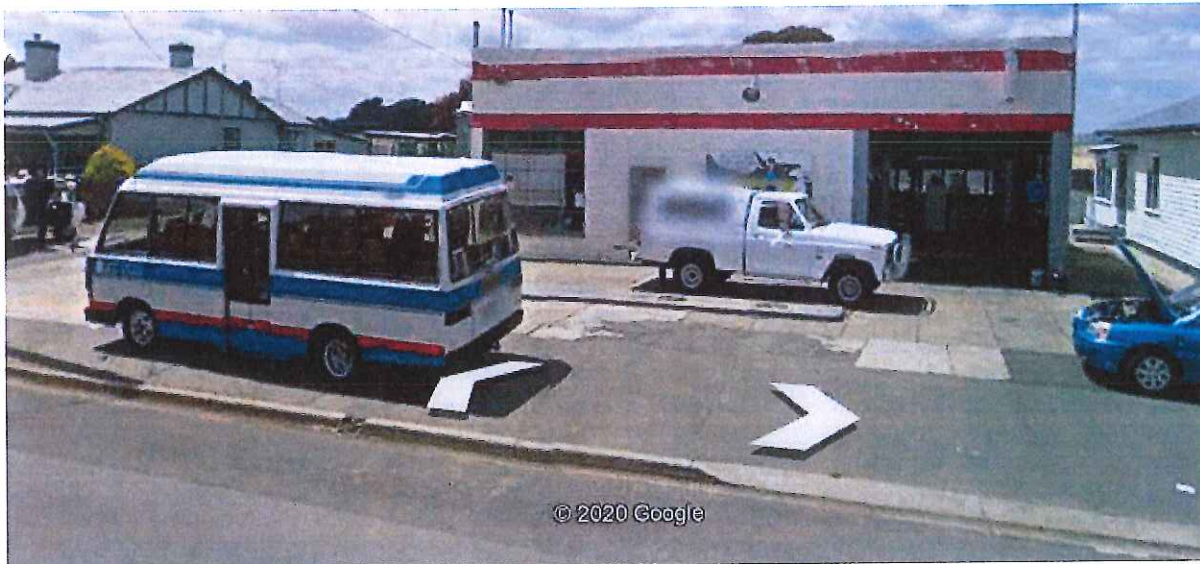
Figure 8: Street view Taken sometime between 2001 and 2018 (Google Earth)

A ground penetrating radar (GPR) was used on 20 July 2020 to identify all remaining underground fuel lines and remaining underground tanks. Possible underground tanks were identified in the footpath and under the roadway located on Council owned land. Northern Midlands Council was notified of the existence of three possible underground tanks located on Council land under the footpath and roadway (Refer to Figures 9 and 10).

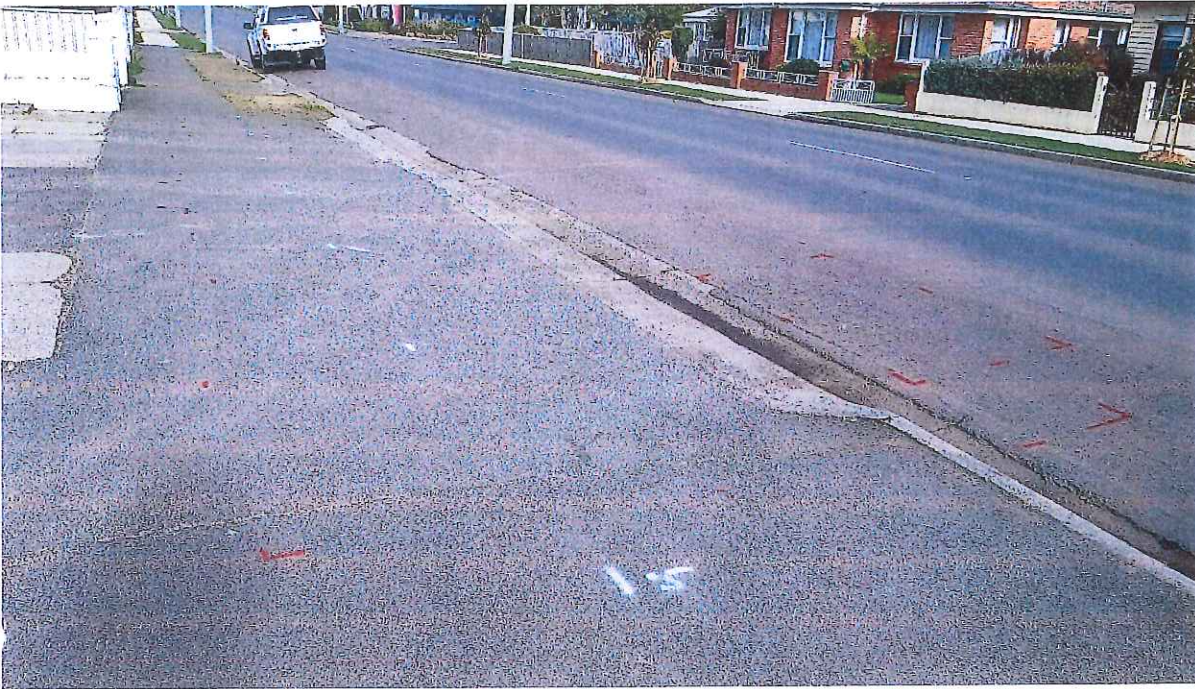
Figure 9: Red outline on roadway is possible underground petroleum tank

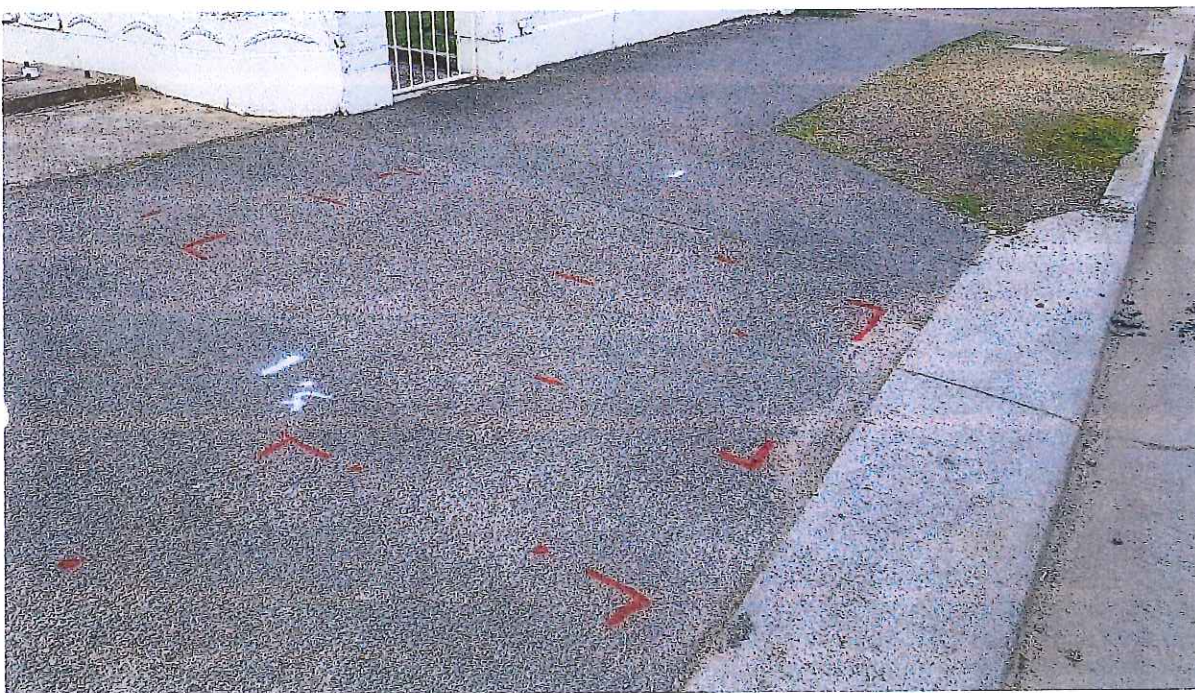
Figure 10: Red outline on footpath are indicating the presence of two possible underground petroleum tanks

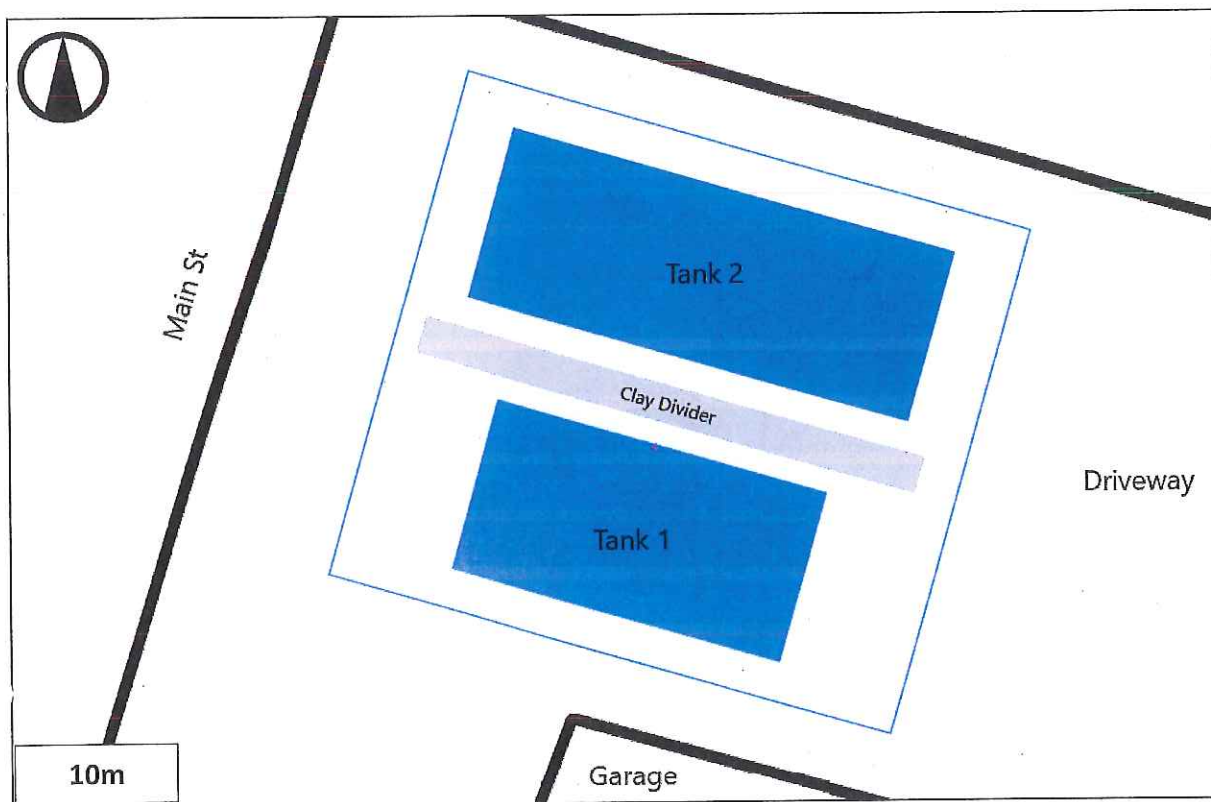
Figure 12: UPSS Detail

Figure 6 shows the layout of the tank pit.

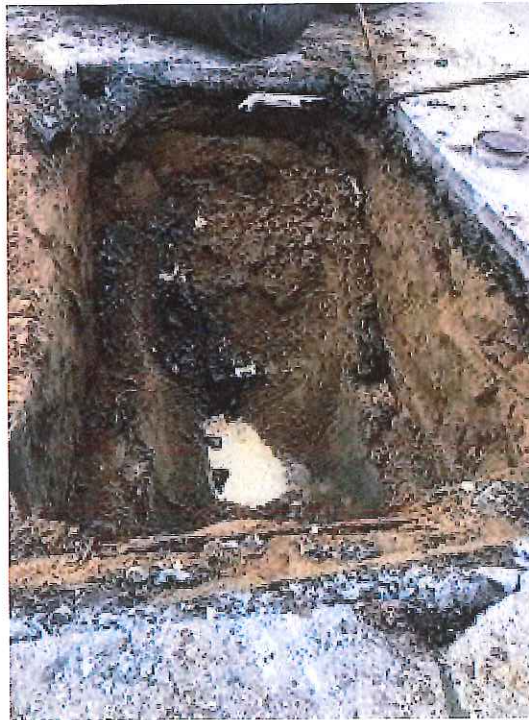
**Figure 14: Tank 1 Pit (Pit 1) After Excavation**

The pit had been backfilled after tank removal on the 26th due to concerns about structural collapse. Photos were taken by Gavandy before the backfill; Figure 7 shows a small amount of surface water in the pit after excavation, and Figure 8 shows the condition of the pit wall.

The pits were re-excavated to a depth of 2.3m BGSL, and a concrete slab was found to be at the bottom of the tank 1 pit. Pit walls and base were sampled as per Chapter 11. No water was encountered.

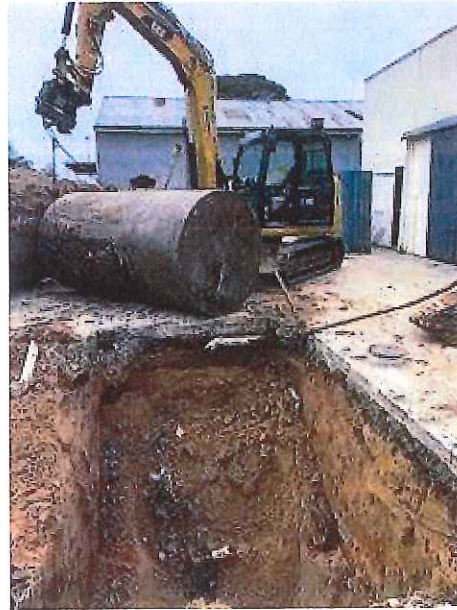
Figure 16: Tank 1

Figure 16 shows tank 1 after excavation. It was found to be in good condition without rust or holes. No water was found in the pit once it was re-excavated.

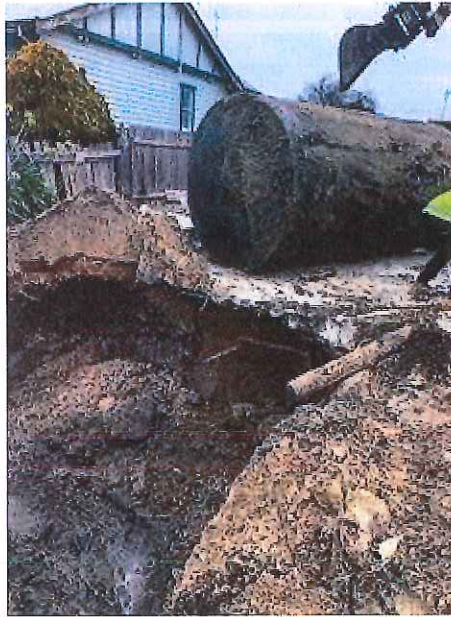
Figure 17: Tank 2

Figure 17 shows tank 2 after excavation. It was found to be in good condition without rust or holes. Dampness in the hole after re-excitation appeared to be coming from a downpipe on the adjacent property.

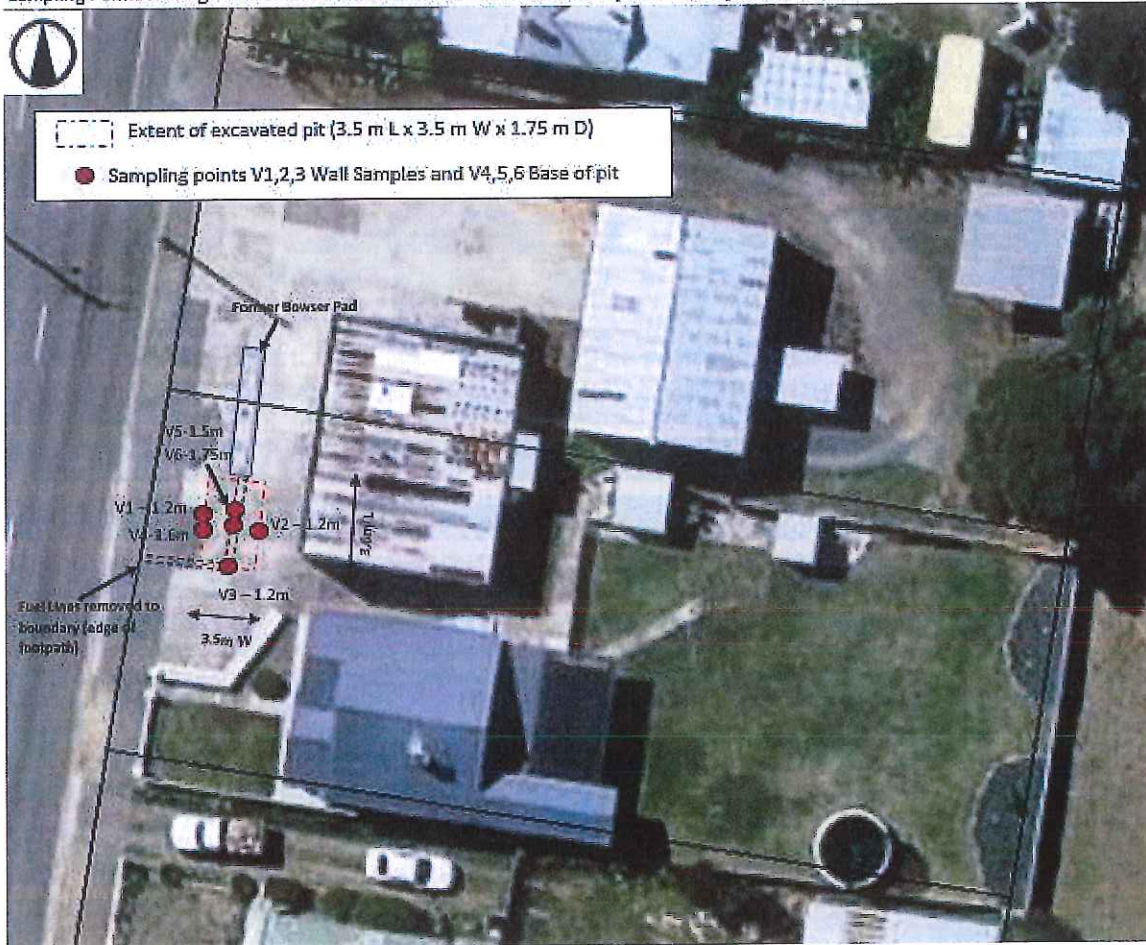
Figure 25: removal of Fuel Lines to the South of former bowser pad.

Sampling Points 26 August- removal of Fuels lines south of the bowser pad and sample excavation pit

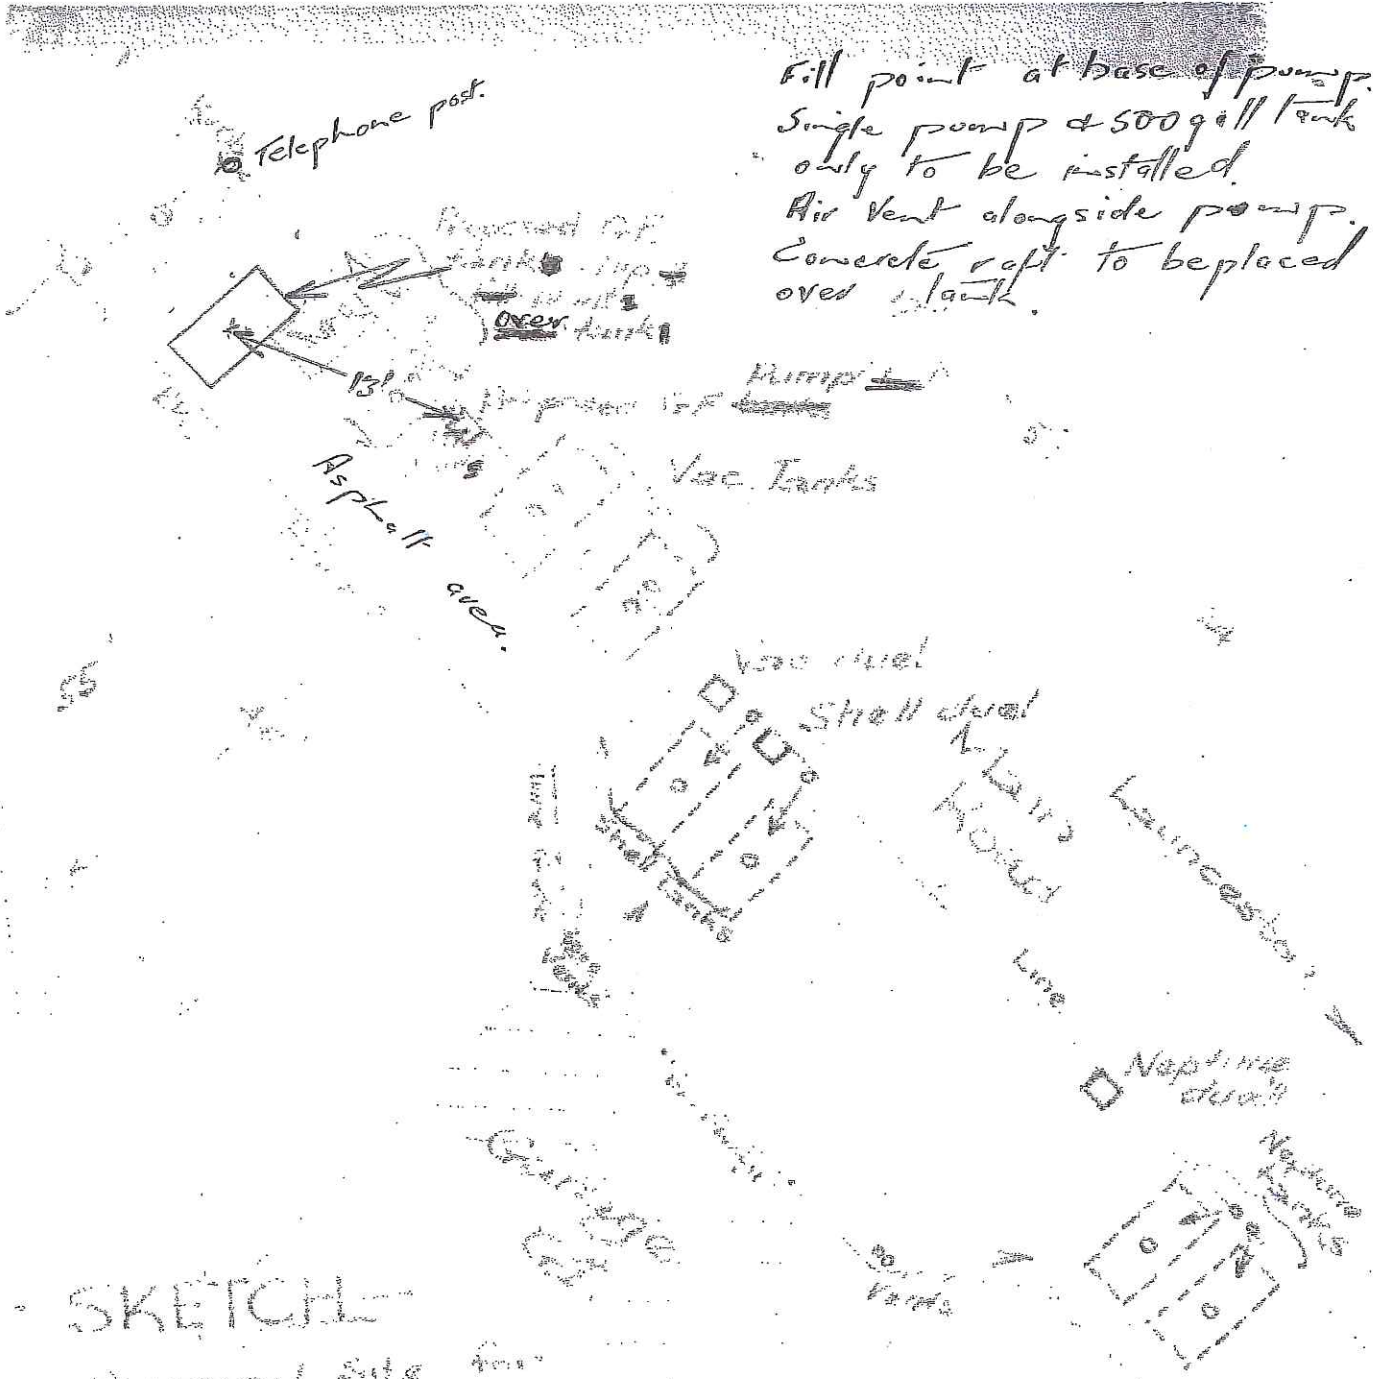
SKETCH

Fill point at base of pump.
 Single pump & 500 gall tank
 only to be installed.
 Air Vent alongside pump.
 Concrete raft to be placed
 over tank.
