### 3. Heritage

### 4. Present Condition of the Bridge.

# Detailed Fabric Assessment

## **Blackman River Bridge, Tunbridge Conservation Management Plan and Heritage Impact Statement**

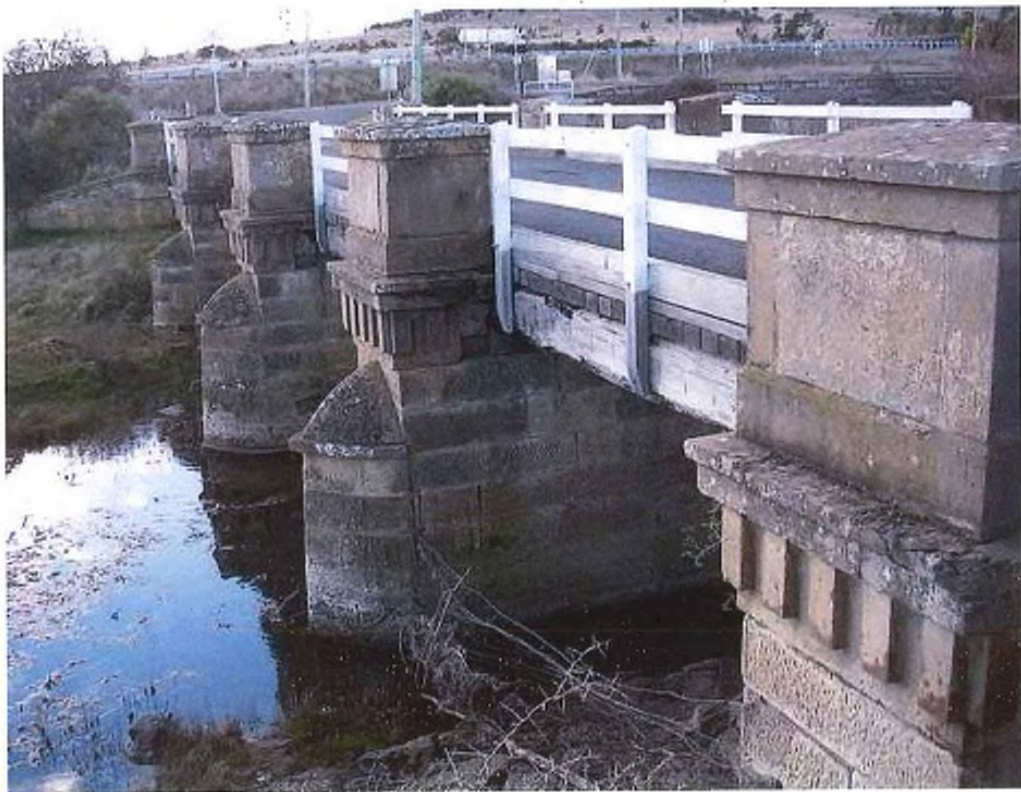
Photograph 2. View of detail of upstream face.

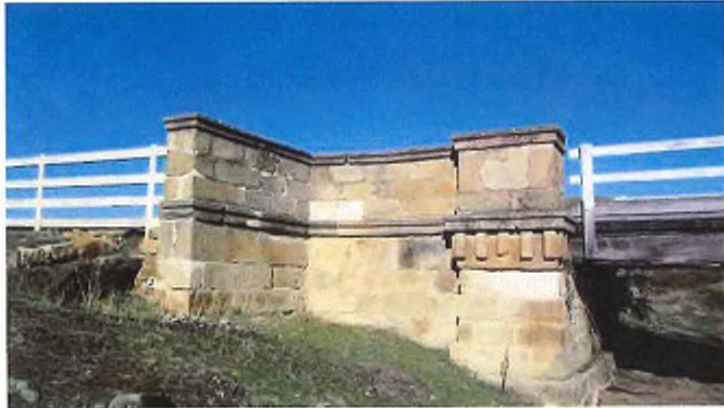
Photograph 3.  
NE abutment. Recent works have been to install an air vent drain behind and to do minor pointing repairs. This is the most weather and sun exposed location on the bridge and was in the worst condition. There is no present fretting but repointing needs to be done wherever defective on the whole bridge.

- The bridge stonework is in generally good condition.
- The sandstone is not good quality and is subject to fretting where weather and sun exposed areas have lost pointings and where water retention occurs. An air vent drain has recently been installed to my recommendation on the NE corner abutment to relieve water stress and associated stone fretting. Repointing and minor repairs were carried out to this stonework at the same time. There is no present indication of fretting.

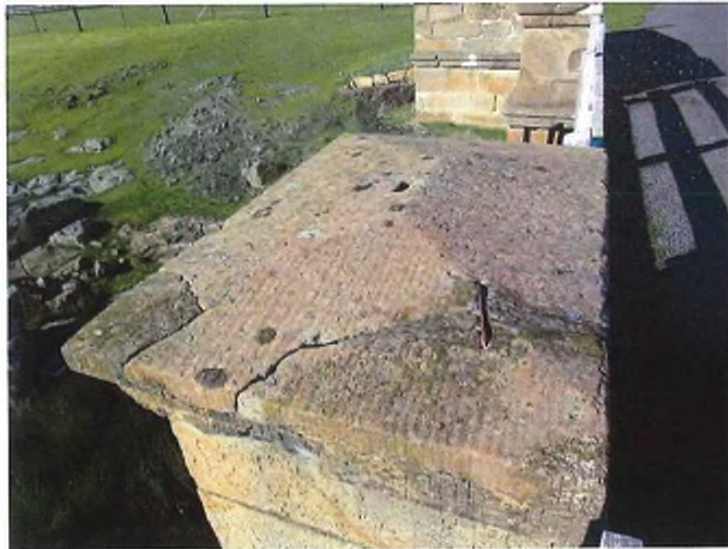
Photograph 4.  
Damaged cap stone on post requiring repair. It is likely evidence of past vehicle impact.

- There is no indication of structural cracking in any of the bridge stonework.
- There is work required to make good minor pointing defects.
- Minor insert repair and crack repair is need to cracked cap stones on some stone posts.

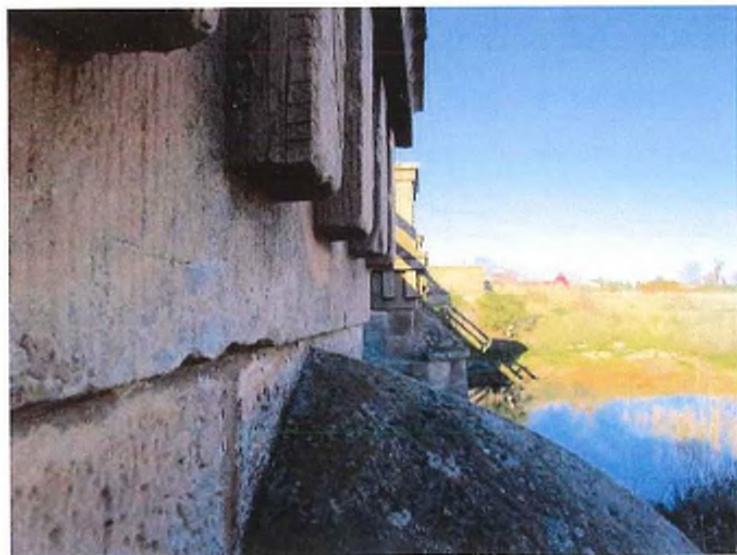
Photograph 5.  
View along bases of posts upstream SE side of bridge. Some posts have been displaced laterally by around 50mm.

- There is indication of movement of some of the stone posts with lateral displacement. The historic record states damage has occurred to some due to vehicle impact and works of raising the deck and of inserting large logs are likely to have moved the posts laterally where movement has been observed. It is evident that the posts would not meet current vehicle impact standards.

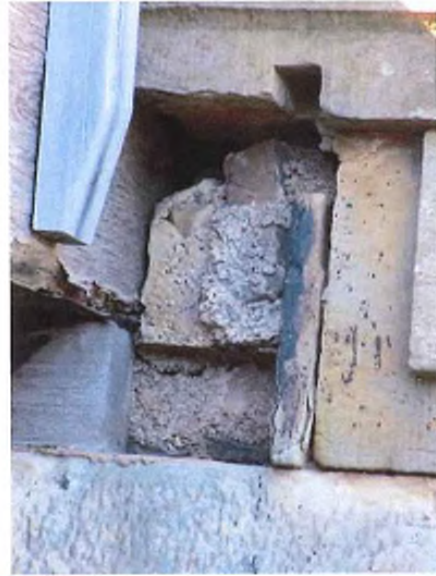
Photograph 6.  
View of log landing onto pier. The post support has partially been removed and the later work with concrete, likely inserted when the deck was raised, is not supporting the post.

- Concrete infill has been inserted around log landings onto the piers and abutments and needs to be evaluated on remedial works uncover. The posts are not supported by these concrete pieces and new work should see the original support replaced.

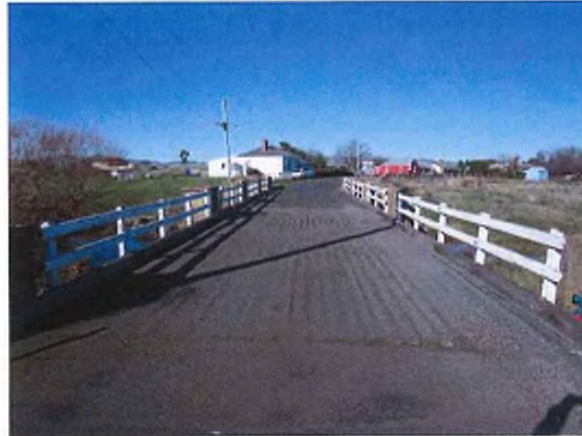
Photograph 7.  
View of deflected longitudinal deck planks with deflections due to wood rot .It is likely all of the bridge timbers require replacing.  
The longitudinal planking is a visual indication of how the bridge was constructed.

- The timber deck planks are rotted beyond repair and deflection of the deck bearers suggests most have rot. The timber logs, where accessible, are shown to be rotting on their top surfaces.

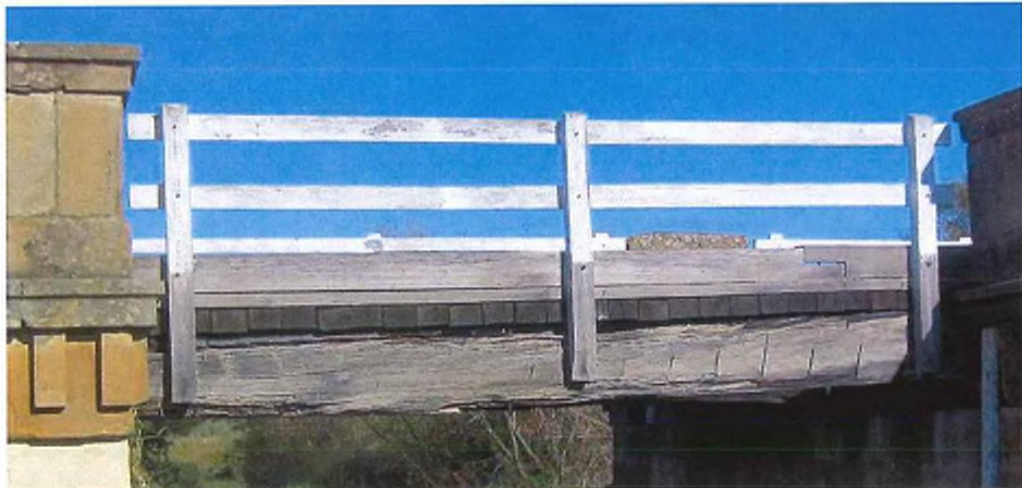
Photograph 8. Side view showing how the bridge was constructed. This is girder bridge construction.

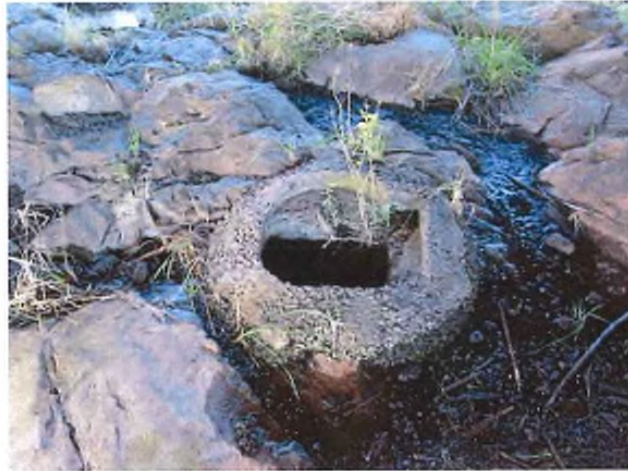
Photograph 9.

An earlier work was to prop the long span on the NW end with a timber cross beam and three timber posts. The concrete footing, one of three, is a record of that past alteration.

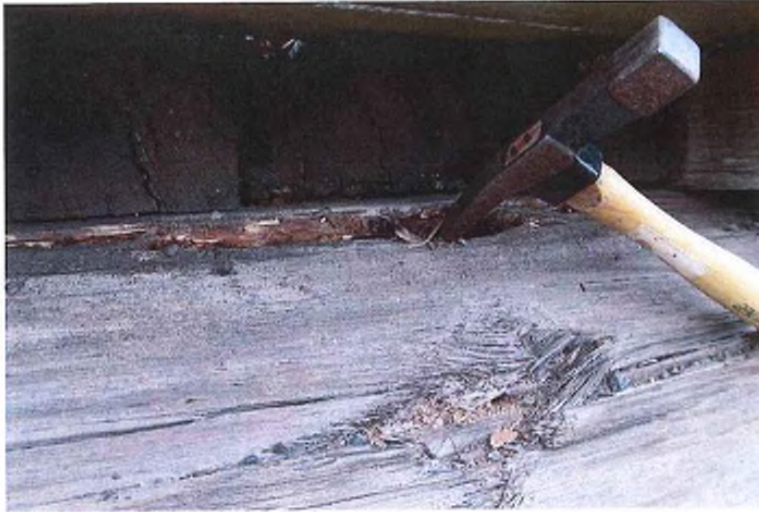
Figure 5: Condition of girder - northern span, western external girder

A series of holes drilled into various girders indicated that the rot extends, in layers, to at least 125 mm inside the girders. Although some girders are in better condition than others (in particular the internal girders are generally in better condition than external girders), all show signs of rot.

With the foregoing observations and in consideration of the previous reports, this report will not attempt to assess the load carrying capacity of the existing timber superstructure. It is assumed that the existing superstructure will be fully replaced as part of any future remediation as it does not appear economical to reuse any parts of it.

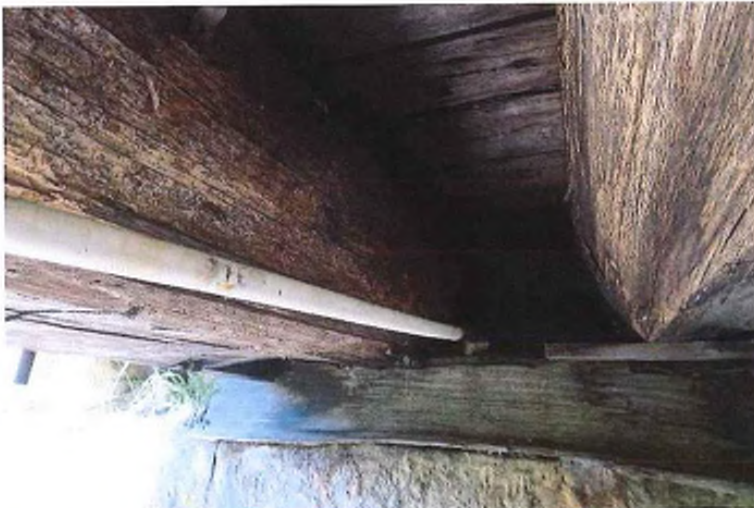
The timber spreader beams, which sit on the top of the piers and abutments and support the main girders, are deeply rotted. Due to the rot, these beams are, in places, collapsing under the weight of the superstructure above. Refer to Figure 6 below, where the spreader beam at the southern abutment is seen to be folding under load.

Figure 6: Timber girders and spreader at southern abutment

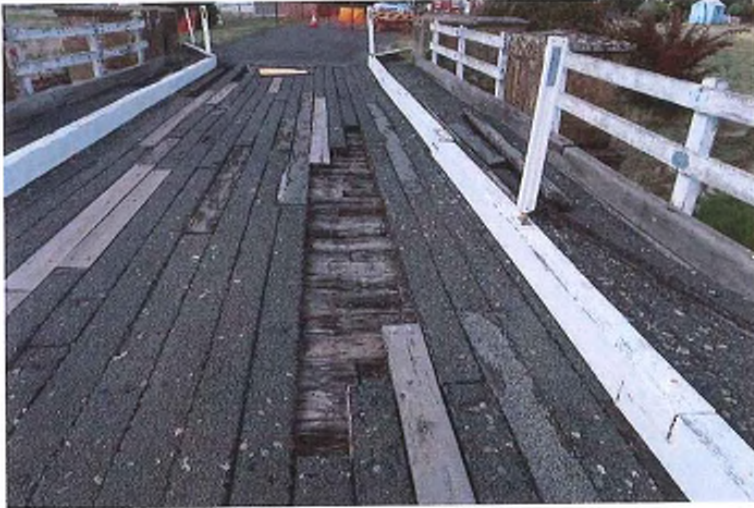
Similarly, the deck of the bridge is in very poor condition, as shown in Figure 7 below. Many top layer deck planks are missing. In some places, both layers of the deck planks are holed and the river below is visible through the deck.

Figure 7: Deck condition

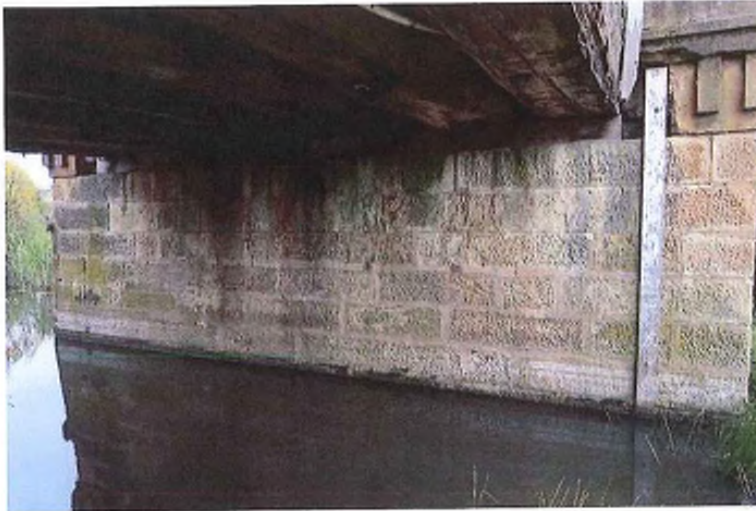
Figure 8: Southern face of the southern pier 1

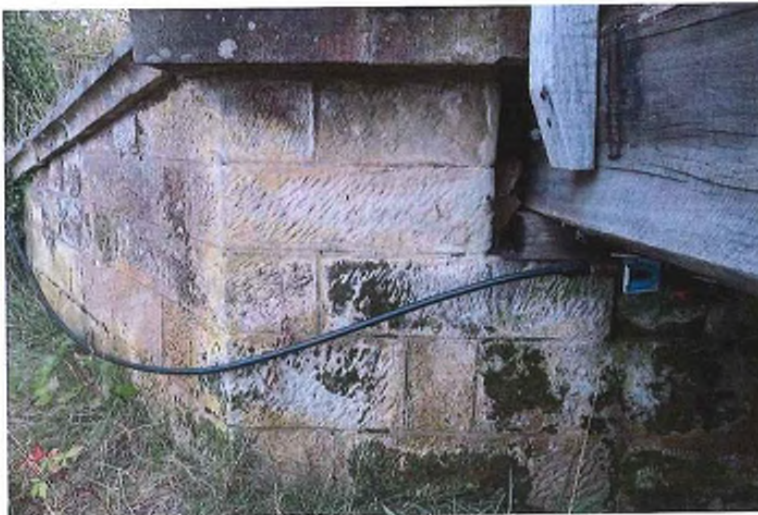
Figure 9: Face of northern abutment

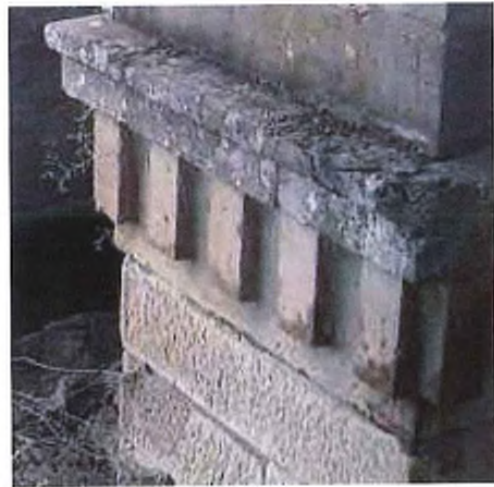
Photograph 1.

- Trial drilling of stretcher pier stones shows them to be 370 thick with a small gap to other stone. There are full pier header stones under the posts suggesting that the piers have full width headers with little rubble infill between stretchers giving good solid construction.

View of full width header stone in pier.

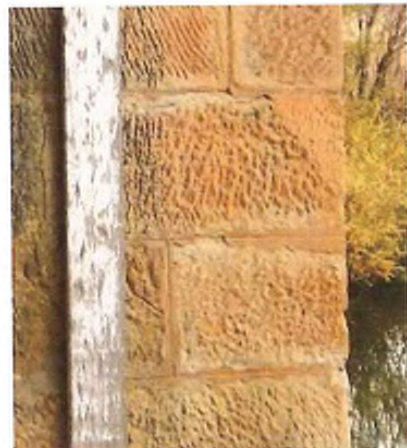
Photograph 2.

- Drilling through bed joints in the piers shows the bedding is site soil with very little quicklime. This was common practice at the time but gives no bond strength and little resistance to washout with water entry following pointing loss.
- There is no structural cracking and no defects requiring attention in the piers and abutments other than the pointings.
- Pointing of stonework is a mix of good quality quicklime and later cement. There is substantial pointing loss in all stone faces.
- There is some damage from water retention and fretting where cement mortars have been used and replacing these mortars in fretting locations is warranted

Fretting at cement pointing.

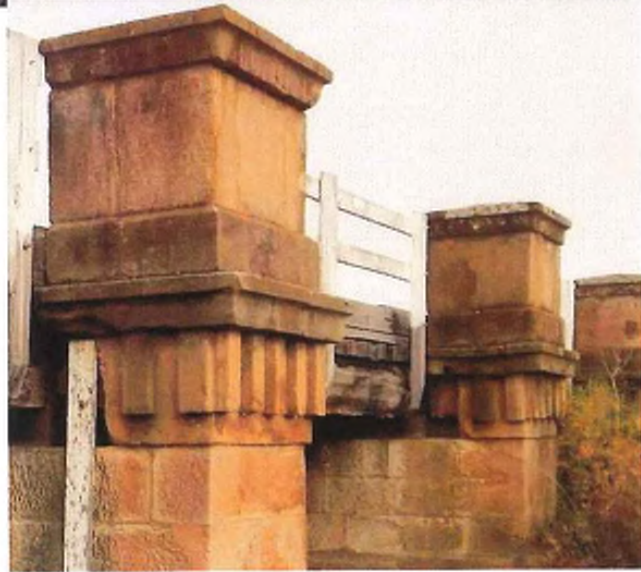
Photograph 4.

- All of the posts exhibit horizontal movements consistent with the historical record of vehicle impact. The posts have been altered with removal of supporting edge stones to allow for the insertion of the timber girders.

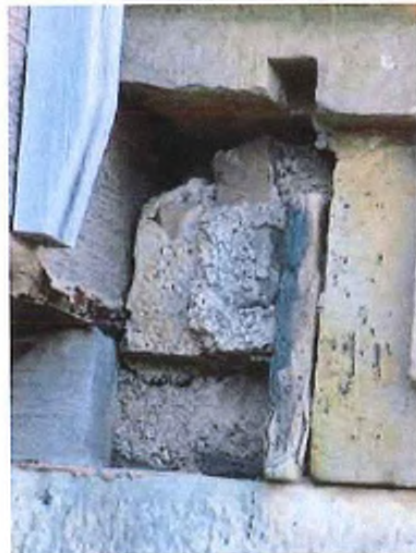
Photograph 5.

- Concrete has been placed around some girders to support the cut back post edge. The work is clearly inadequate.

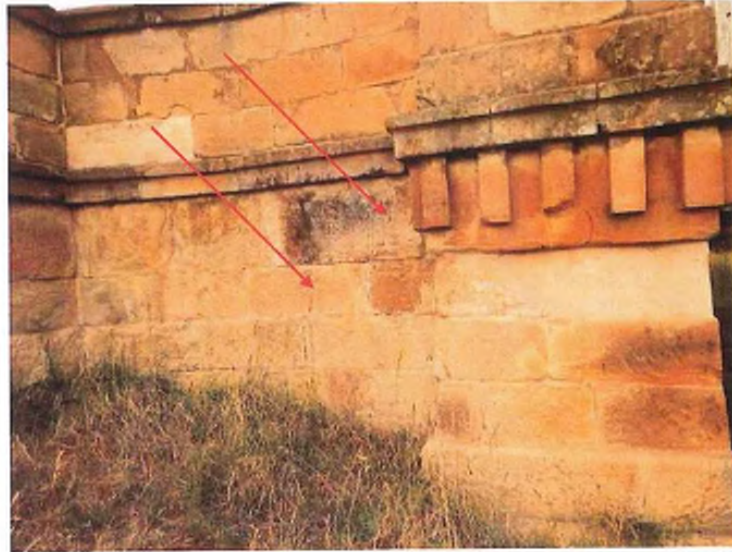
Photograph 6.

- The change in stone heights on the eastern abutment suggests an alteration in adding height with a later extra height stone course.

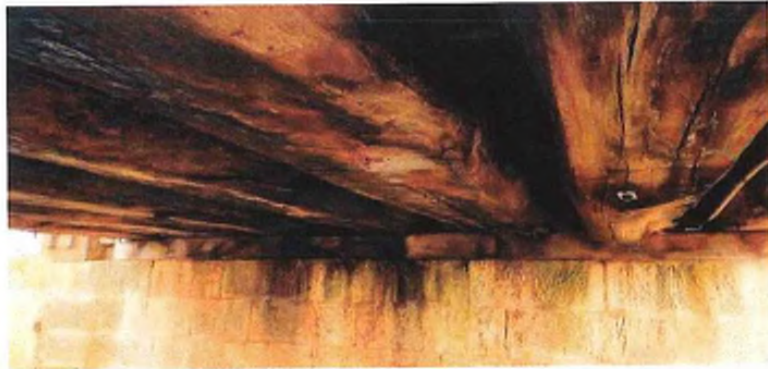
Photograph 7.

- There is significant rainwater runoff onto the eastern abutment.

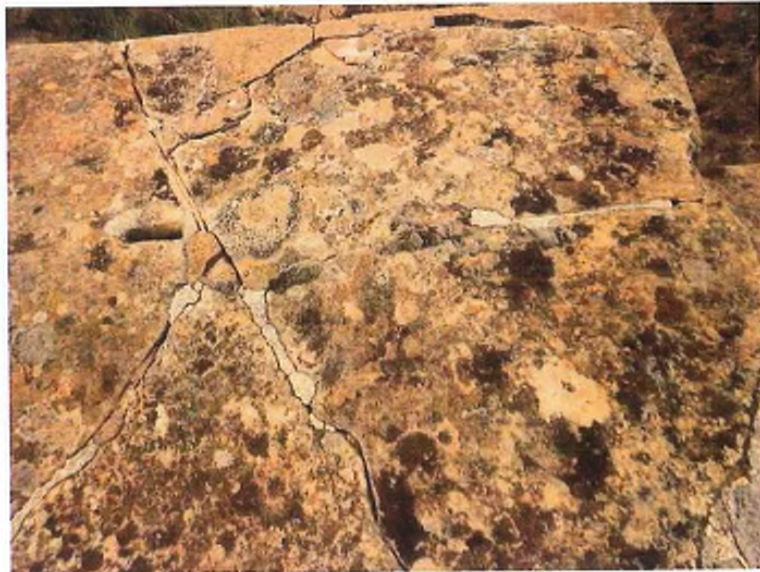
Photograph 8.

- Cracked and previously repaired post cap stone.

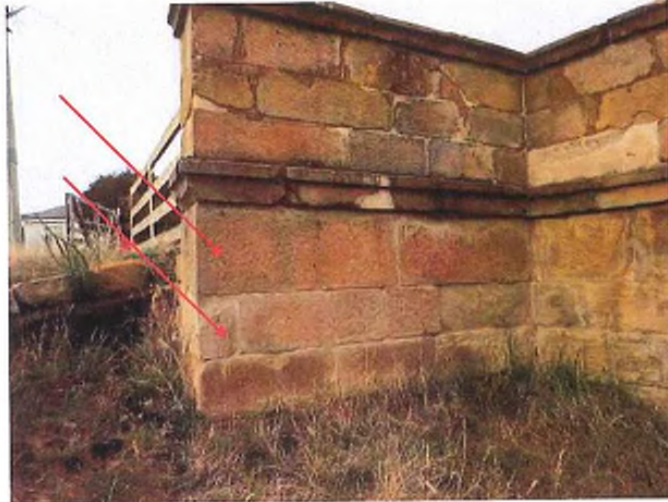
Photograph 9.

- View of eastern abutment, northern wall. Previous extensive stone fretting from rising damp due to downhill water runoff has been controlled by an air vent drain installed by Spratt around 8 years ago. Note stone height change.

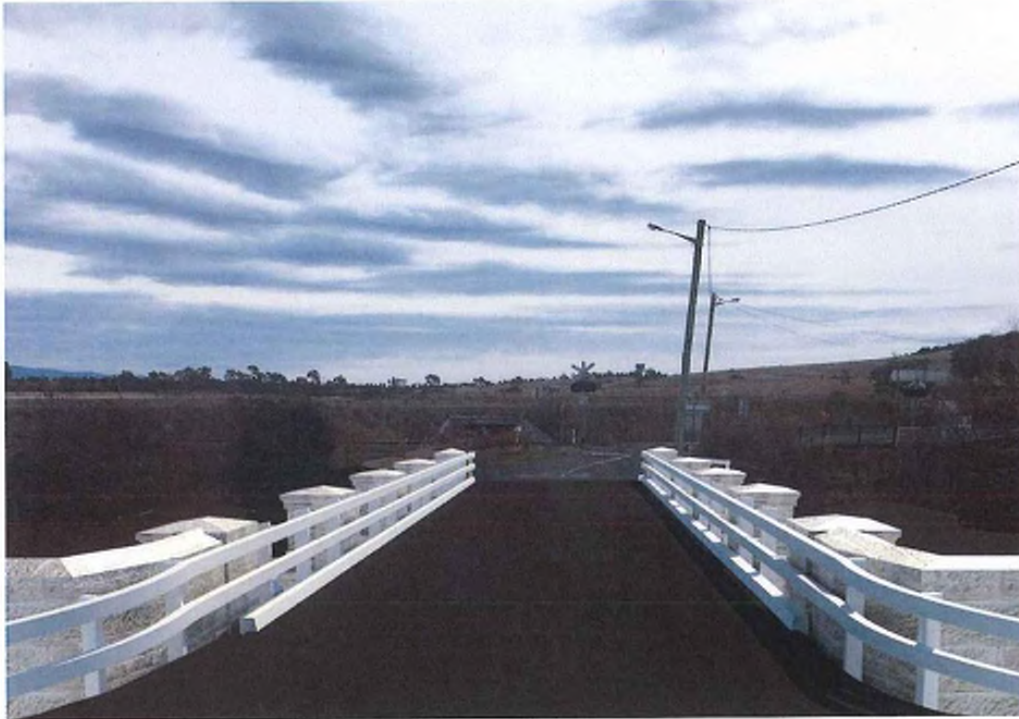
Figure 7: Visualisation of the renewed deck and railings (Pitt & Sherry)
