Blackman River Bridge, Tunbridge:
 Conservation Management Plan & Heritage Impact State
 Austral Tasmania Pty Ltd ABN: 11 133 203 488

Due to the current condition of the bridge, Department of State Growth (DSG) commissioned pilt&sherry to provide engineering design support for a significant refurbishment. Following discussions with the two councils in late 2020, SMC requested that a Conservation Management Plan (CMP) be prepared for the bridge. At DSG's request, pilt&sherry engaged Austral Archaeology to prepare the CMP.

The first iteration of the present Blackman River Bridge at Tunbridge was constructed in June 1848¹. Initially the bridge consisted of a 3-span (equal span lengths) timber bridge with sandstone abutments and piers². Between 1894 and 1897, the bridge was modified to its current arrangement, whereby the northern sandstone abutment was converted to a pier and a new abutment was constructed to create an additional span.

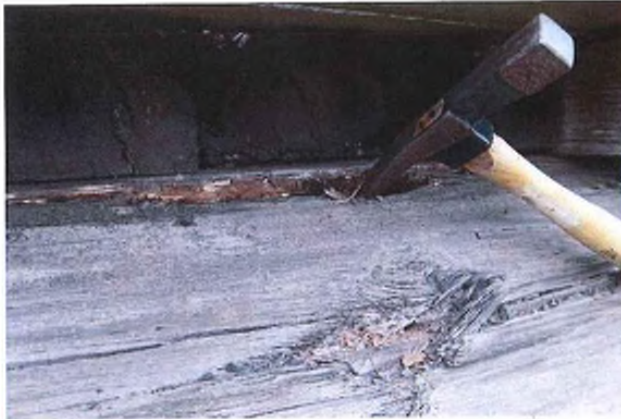
This viewpoint was further reinforced following several more recent visits to the site by pitt&sherry staff including in August 2020, December 2020 and April 2021. It is apparent that the timber rot in the beams and deck planks is progressing, as indicated in Figure 5 below.

Figure 5: Condition of girder - northern span, western external girder

A series of holes drilled into various girders indicated that the rot extends, in layers, to at least 125 mm inside the girders. Although some girders are in better condition than others (in particular the internal girders are generally in better condition than external girders), all show signs of rot.

The existing timber structure, including the existing traffic barriers, is unfit for purpose in nearly all aspects. The bridge is currently closed to both vehicles and pedestrians and this is justified due to rotting girders and rotting or missing deck planks. It is recommended that all timber components of the bridge be replaced.

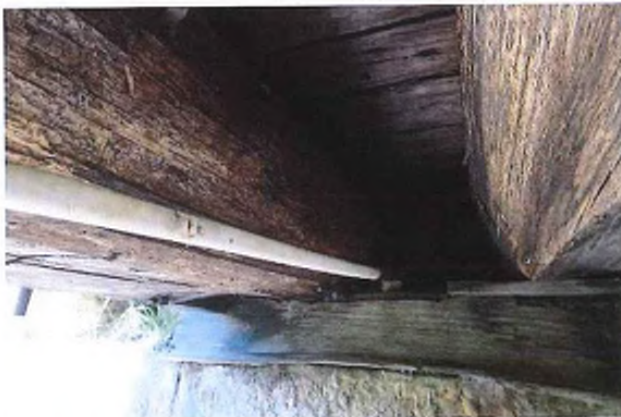
The timber spreader beams, which sit on the top of the piers and abutments and support the main girders, are deeply rotted. Due to the rot, these beams are, in places, collapsing under the weight of the superstructure above. Refer to Figure 6 below, where the spreader beam at the southern abutment is seen to be folding under load.

Figure 6: Timber girders and spreader at southern abutment

Any future superstructure replacement should account for adequate load spreading from the beams into the top of the sandstone piers and abutments. Currently this is achieved by means of timber spreader beams, however the ongoing use of this same timber is clearly unsatisfactory given the amount of rot noted whilst on site. Alternative options may include timber of a more durable nature, galvanised steel or a cast in situ concrete spreader (with due consideration given to preventing moisture from accumulating at the concrete/sandstone interface).

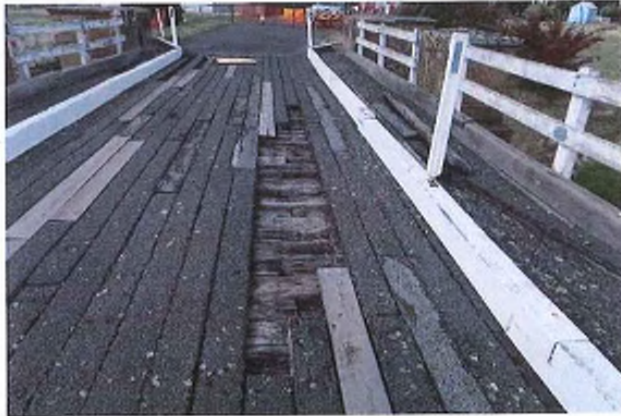
Similarly, the deck of the bridge is in very poor condition, as shown in Figure 7 below. Many top layer deck planks are missing. In some places, both layers of the deck planks are holed and the river below is visible through the deck.

Figure 7: Deck condition

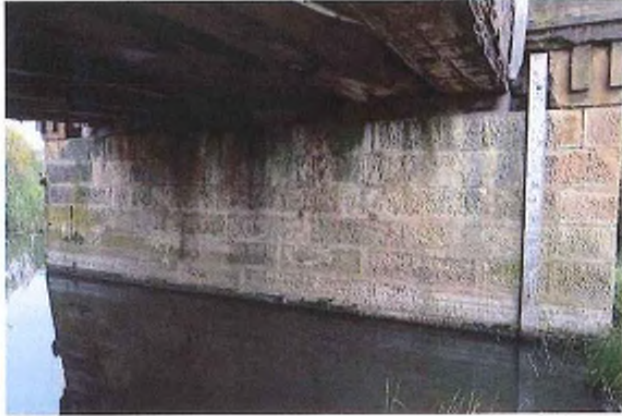
The sandstone substructure is in good condition. The sandstone blocks are solid and there is no evidence of significant movement or cracking in the abutments or piers, despite their use for over 170 years.

An inspection involving Peter Spratt, Edrei Stanton (Tasmanian Heritage Masonry) and Bjorn Jensen (pitt&sherry) on 1 April 2021, found that some repairs of jointing and blockwork are necessary, particularly to the sandstone columns. Nonetheless, the load carrying capacity of the sandstone piers and abutments is assessed to be fully intact. Figure 8 and Figure 9 below show examples of the sandstone substructure and its condition.

Figure 8: Southern face of the southern pier 1

The sandstone sub-structure of the bridge is in very good condition given its age. There is no evidence of structural degradation in the sandstone sub-structure, although we note that the recent *Detailed Fabric Assessment*, recommends that preventative maintenance should be carried out to the sandstone elements.

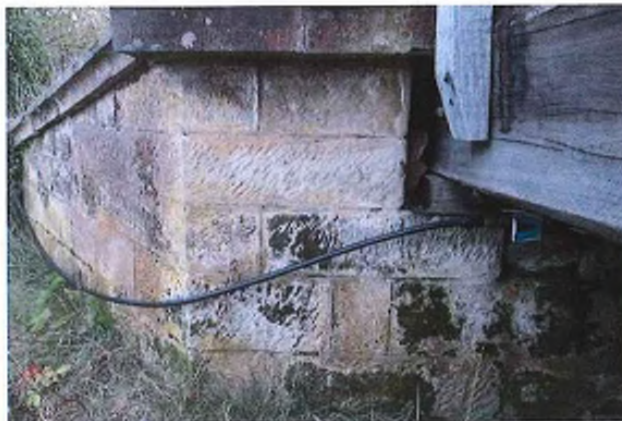
Figure 9: Face of northern abutment

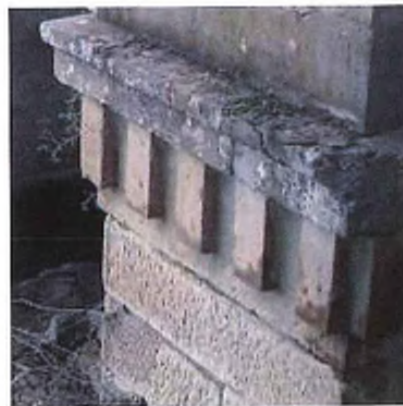
Photograph 1.

- Trial drilling of stretcher pier stones shows them to be 370 thick with a small gap to other stone. There are full pier header stones under the posts suggesting that the piers have full width headers with little rubble infill between stretchers giving good solid construction.

View of full width header stone in pier.

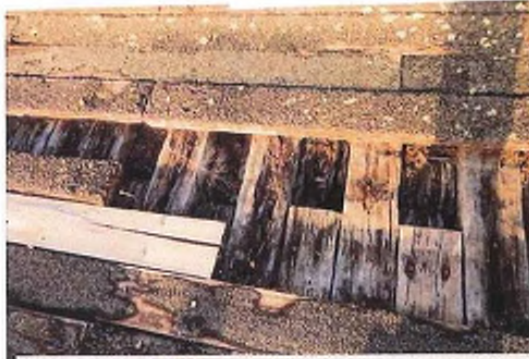
Photograph 3.

- There is severe rot in all deck timbers and drilling of the girders shows severe internal rot.

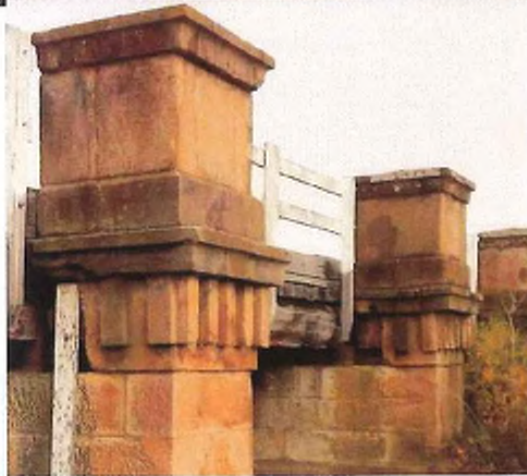
Photograph 4.

- All of the posts exhibit horizontal movements consistent with the historical record of vehicle impact. The posts have been altered with removal of supporting edge stones to allow for the insertion of the timber girders.

1. Replace and make good missing, defective and cracked stonework to posts.
2. Reface stonework on eastern abutment where face fretting exceeds 15mm.
3. Remove cement pointings where fretting is occurring.
4. Make good defective pointings in piers and abutments.

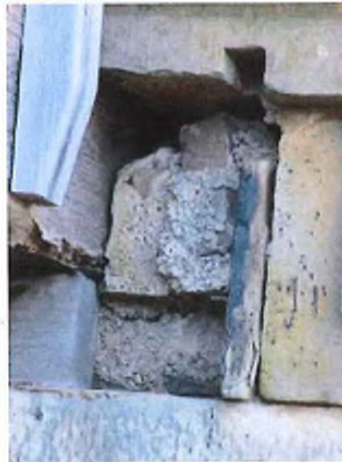
Photograph 5.

- Concrete has been placed around some girders to support the cut back post edge. The work is clearly inadequate.

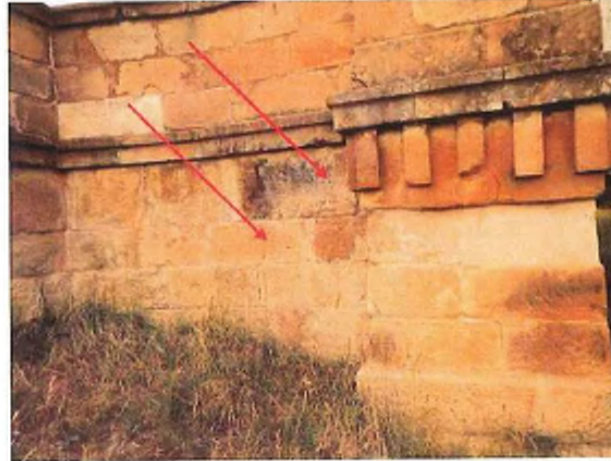
Photograph 6.

The original section of the bridge is the Eastern abutment but it appears to have been raised as indicated in photographs 6 and 9 below. This aligns with the 1889 specification requiring level adjustments. The three present piers are not equally spaced. It is unknown as to whether the present spacing reflects foundation conditions, which pier has been inserted or whether new piers were constructed. The piers were not mentioned in the 1889 specification. The western abutment and its wing wall are an 1894-97 construction.

- The change in stone heights on the eastern abutment suggests an alteration in adding height with a later extra height stone course.

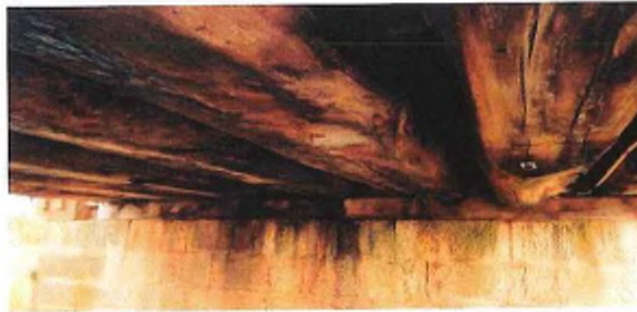
Photograph 7.

- There is significant rainwater runoff onto the eastern abutment.

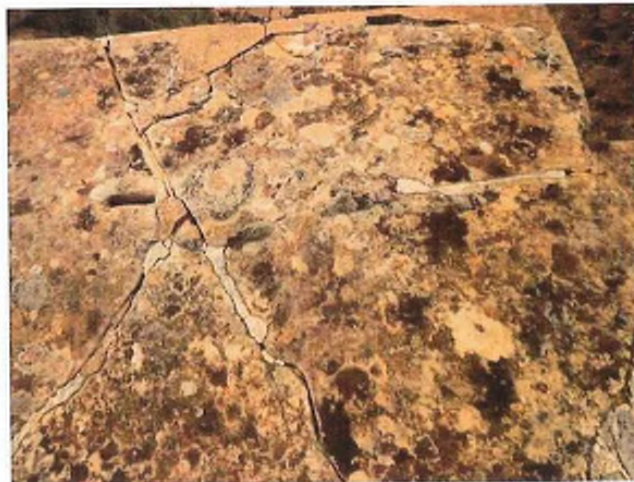
Photograph 8.

- Cracked and previously repaired post cap stone.

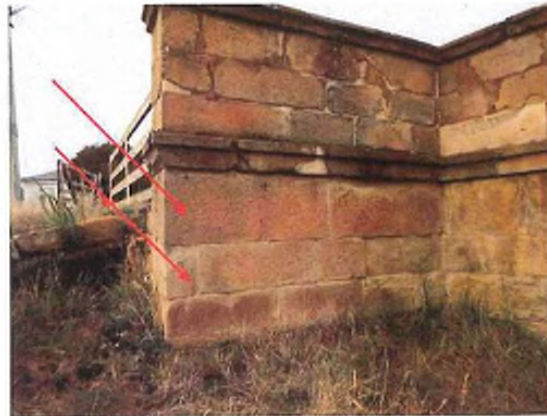
Photograph 9.

- View of eastern abutment, northern wall. Previous extensive stone fretting from rising damp due to downhill water runoff has been controlled by an air vent drain installed by Spratt around 8 years ago. Note stone height change.
