This report has been undertaken on behalf of Scott Colvin (the proponent) to support an application for visitor accommodation at 157 Blackwood Creek Road, Blackwood Creek TAS 7301.

Bushfire Hazard Assessment Report & Bushfire Hazard Management Plan

157 Blackwood Creek Road, Blackwood Creek

Agricultural assessment and compliance report

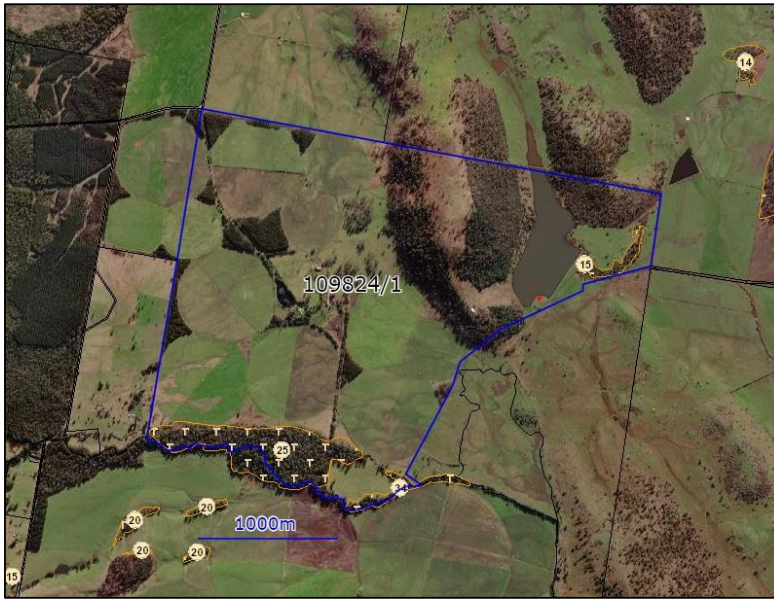
Figure 5. Threatened Native Vegetation Communities (orange outlines) of *Eucalyptus viminalis* wet forest (25) and Riparian scrub (34) along the southern boundary and *Eucalyptus amygdalina* inland forest and woodland (15) along the northeast boundary of the property (Source: The LISTMap).

There are Threatened Native Vegetation Communities (TNVC 2020) of *Eucalyptus viminalis* wet forest and Riparian scrub along the southern boundary and *Eucalyptus amygdalina* inland forest and woodland along the northeast boundary of the property (Figure 5).

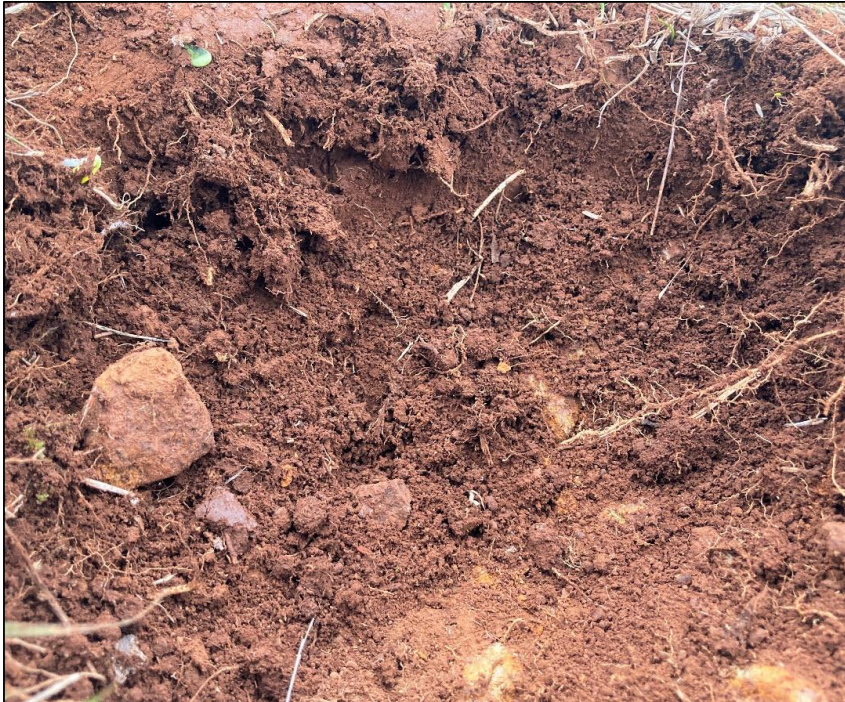
Image 1. Eastfield SPC soil profile 1 on Class 6 land. Shallow (approx. 10cm), red - reddish brown, loam topsoil over clay, developed on dolerite hills. Presence of stones and dolerite fragments throughout profile with limiting layer of rocks (taken at site assessment on 29/04/22).

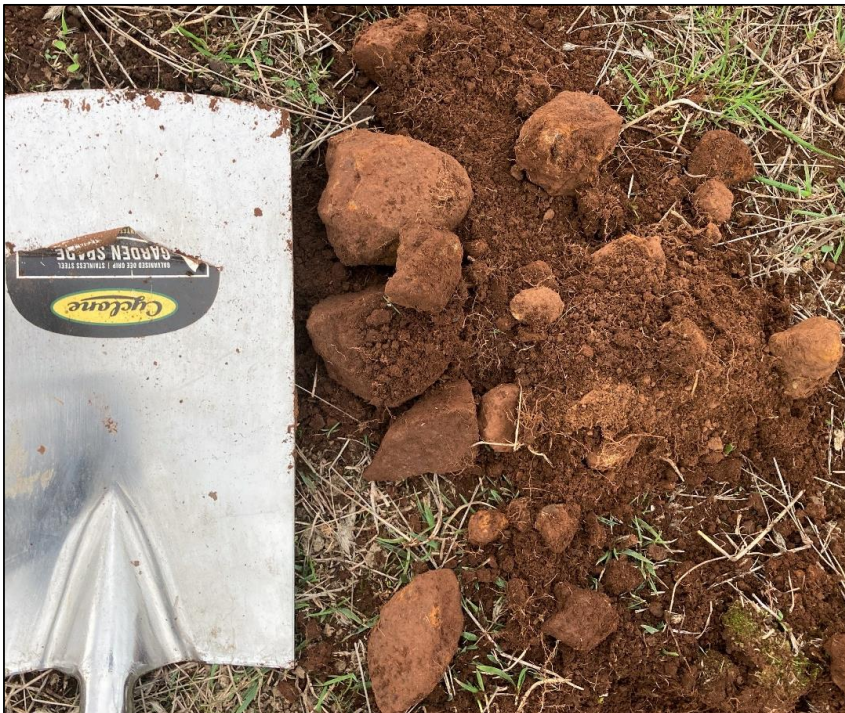
Image 2. Varying sizes of stone from the shallow soil profile 1 in Class 6 land (taken at site assessment on 29/04/22).

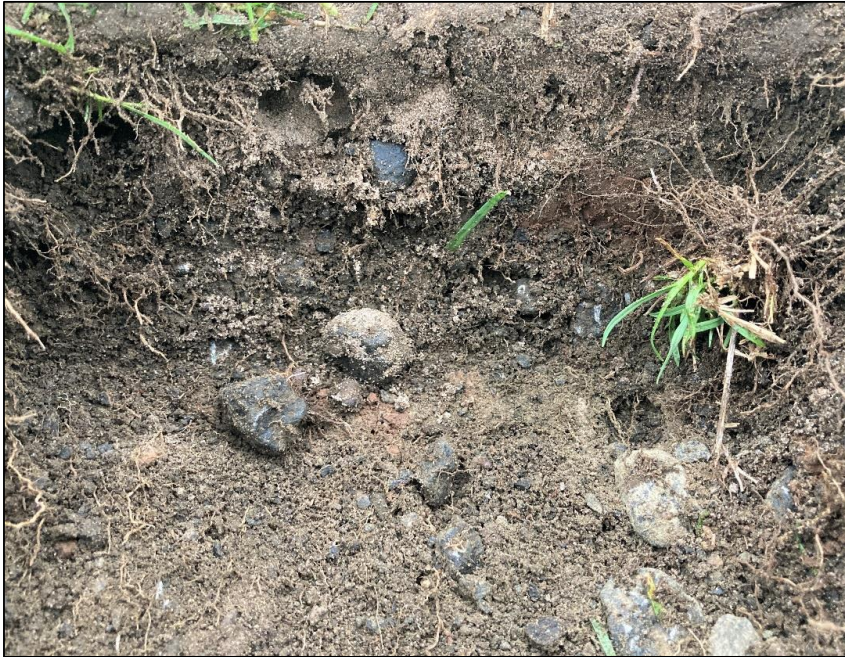
Image 3. Eastfield SPC soil profile 2 on foothills of Class 6 land. Shallow (approx. 10cm), black sandy loam overlying light grey fine sand subsurface on compacted clay. Presence of stones and ironstone nodules throughout profile (taken at site assessment on 29/04/22).

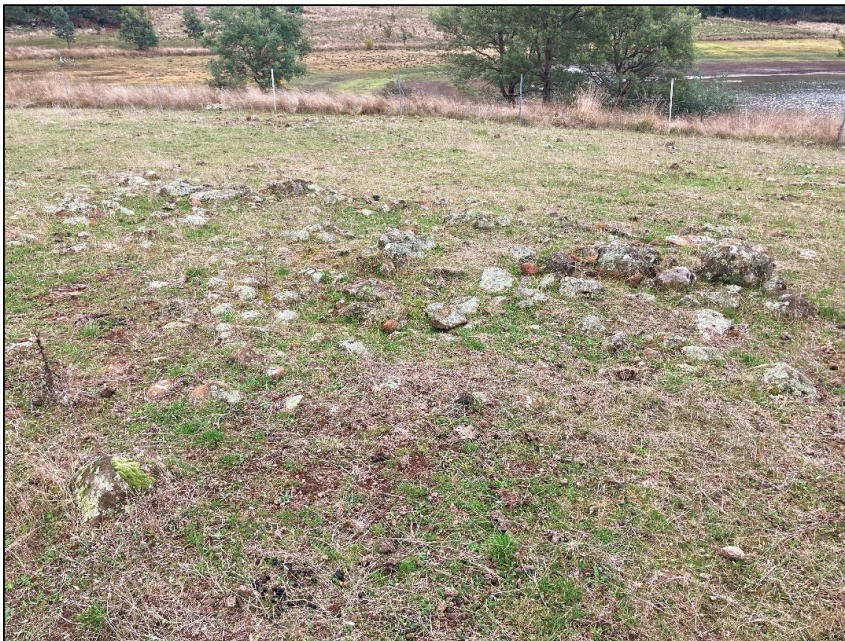
Image 4. Frequent and abundant rocky outcrops on Class 6 land, near proposed development area (taken at site assessment on 29/04/22).

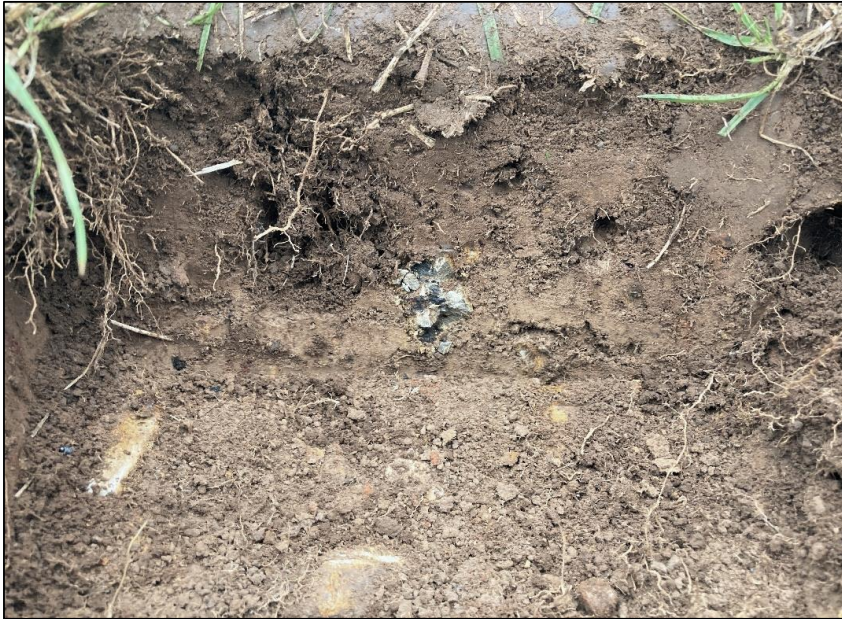
Image 5. Eastfield SPC Soil profile 3 on Class 5 land to the east of proposed development. Shallow, grey-brown sandy loam surface overlying a light grey fine sandy loam subsurface. Presence of stones and dolerite fragments throughout profile with limiting layer of rocks (taken at site assessment on 29/04/22).

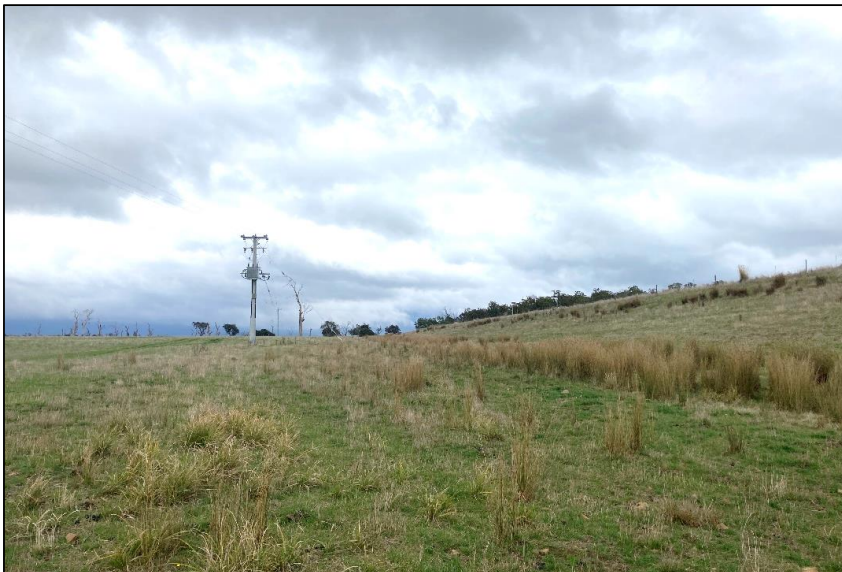
Image 6. Class 5 land to the east of proposed development. Overhead powerlines pass through in this section of land (taken at site assessment on 29/04/22).

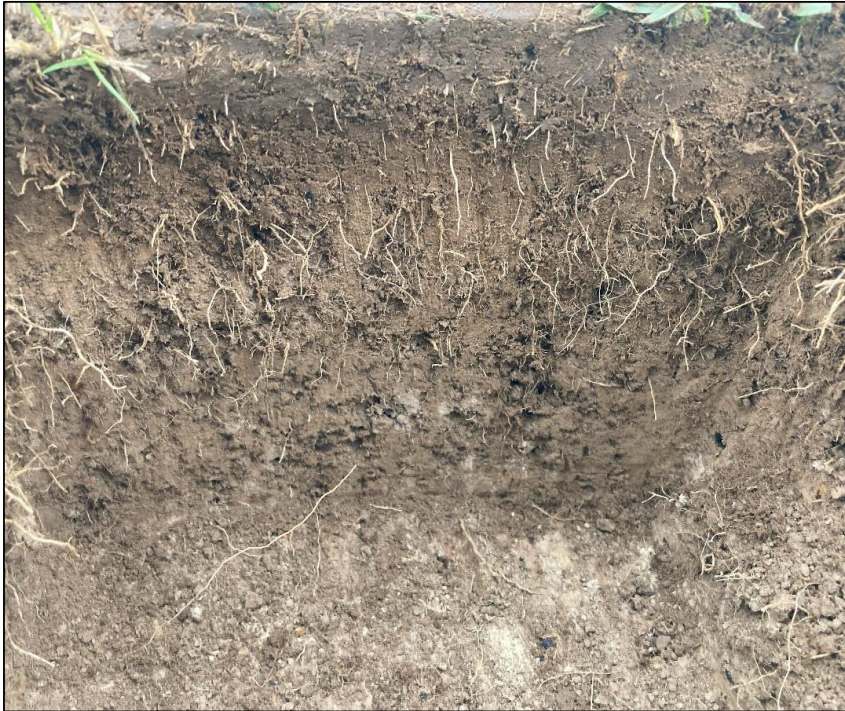
Image 7. Eastfield SPC Soil profile 4 on Class 5 land to the west of proposed development. Grey-brown loam surface overlying a light grey fine silty, sandy loam subsurface. Presence of coarse fragments throughout (taken at site assessment on 29/04/22).

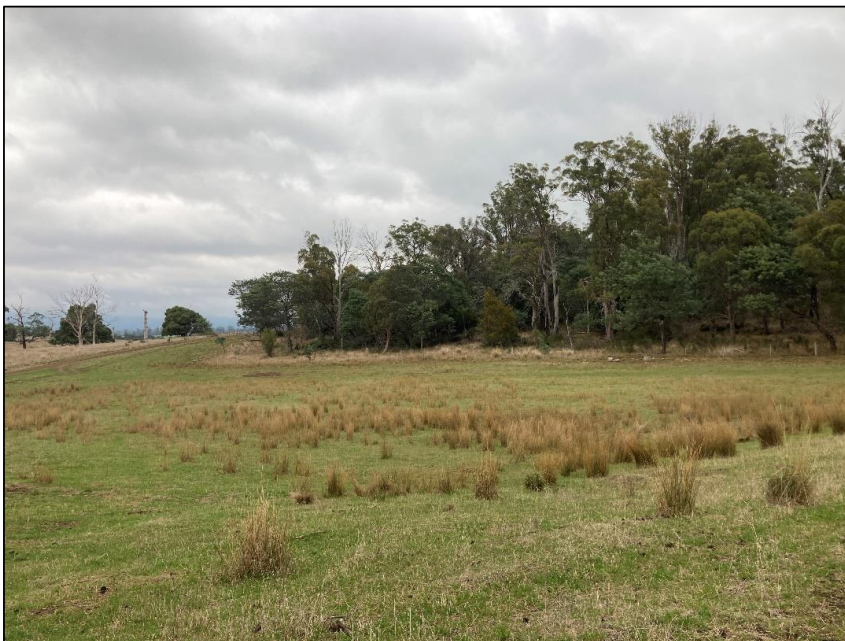
Image 8. Class 5 land to the west of proposed development. This area is prone to waterlogging (taken at site assessment on 29/04/22).

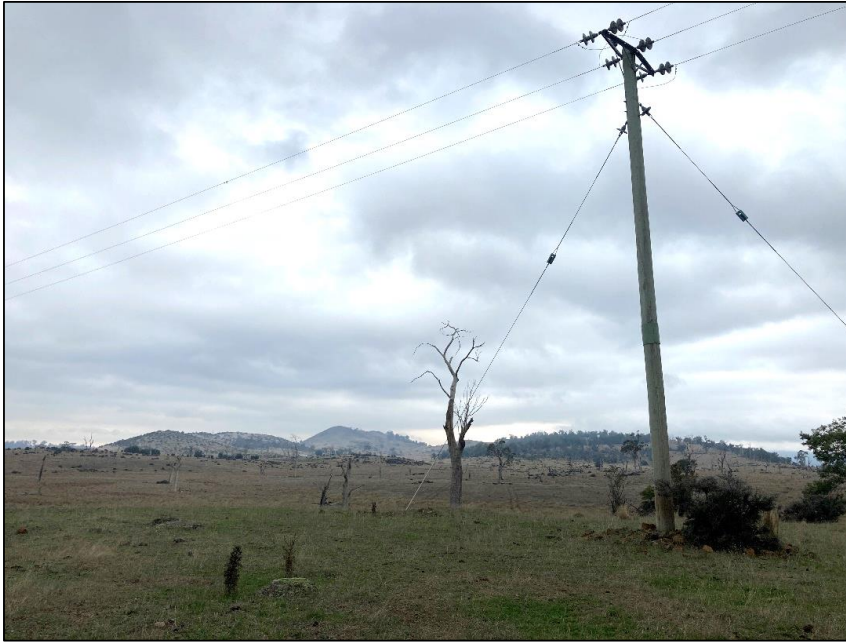
Image 9. Overhead powerlines and electric pole near proposed development site (taken at site assessment on 29/04/22).

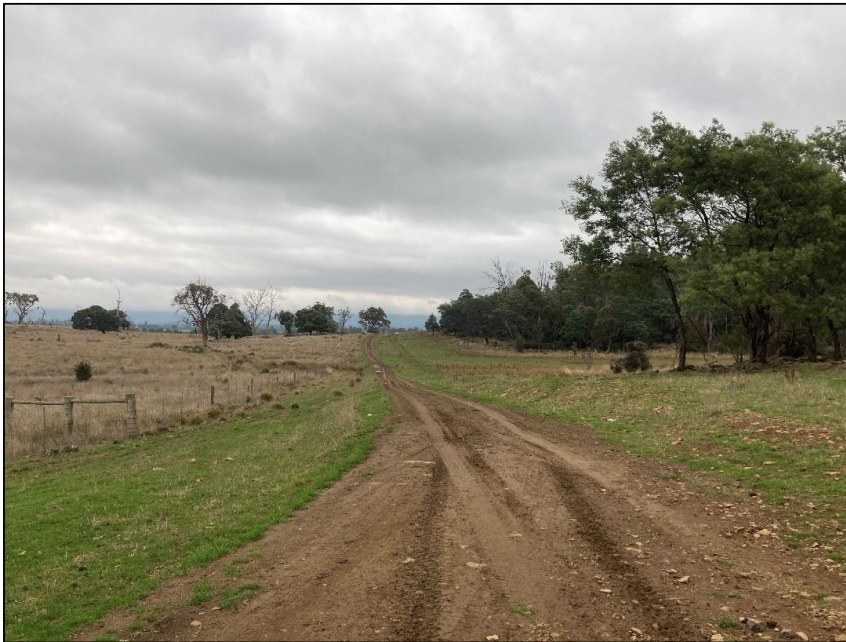
Image 10. Existing laneway along southern property boundary near proposed development site (taken at site assessment on 29/04/22).

The proponents propose to build visitor accommodation on the Class 6 land at the southern end of the approximately 1155ML irrigation dam on the property. The area for the proposed development has been strategically selected to avoid any potential conflict with agricultural activities on the property and adjoining property. The location is atop a low hill, approximately 40m south of the dam and away from the existing farm laneway. The area is not utilised for grazing due to presence of powerlines and abundant rocky outcrops.

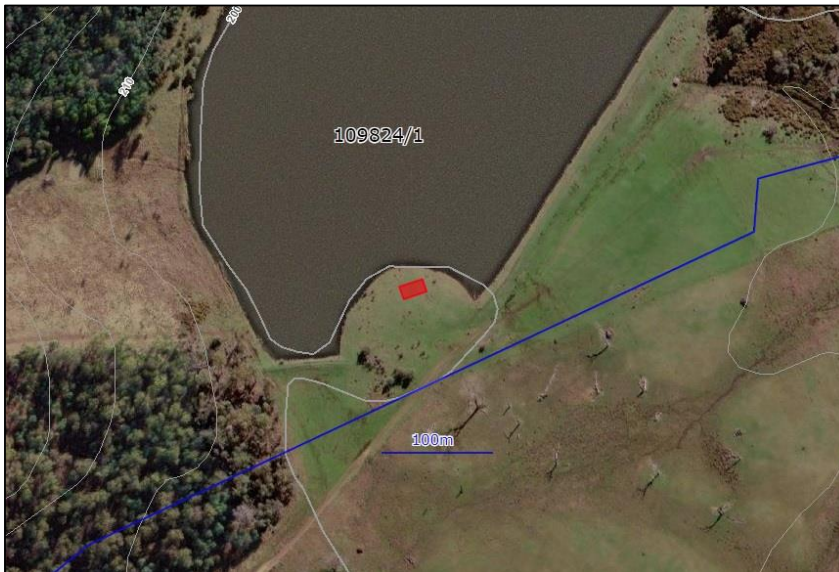
Figure 9. Approximate location of the proposed visitor accommodation at the property shown in red. Blue line indicates property boundary (Source: The LISTMap).

There are no residential dwellings on neighbouring land within 1km vicinity of the proposed visitor accommodation at 157 Blackwood Creek Road, apart from the manager's residence at the subject property (Figure 9). There is no dwelling within 200m of the proposed dwelling for visitor accommodation (Figure 9). The nearest neighbouring amenity (manager's residence on property) from the proposed visitor accommodations is approximately 465m to the west and separated by trees and topography.

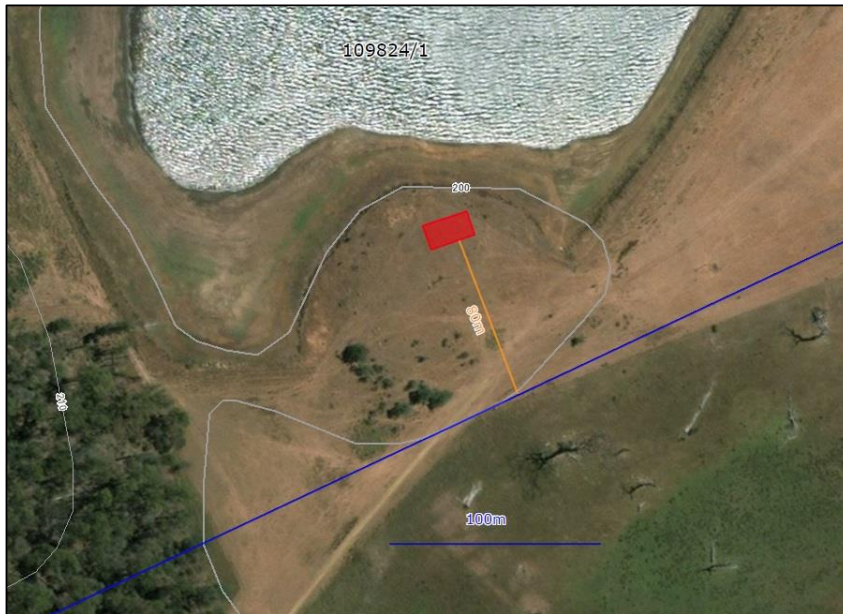
Figure 10. Proposed dwelling for visitor accommodation (red fill) from southern title boundary (blue line) is setback approximate 80m (orange line). All other boundaries area more than 800m away (Source: The LISTMap).

The setback of the proposed dwelling from adjoining agricultural land to the south is further aided by topography and existing farm laneway. This area of the property is not cropped or intensively grazed. Cropping and grazing paddocks to the east and west are separated from the proposed visitor accommodation by topography and vegetation, in addition to being more than 500m away.

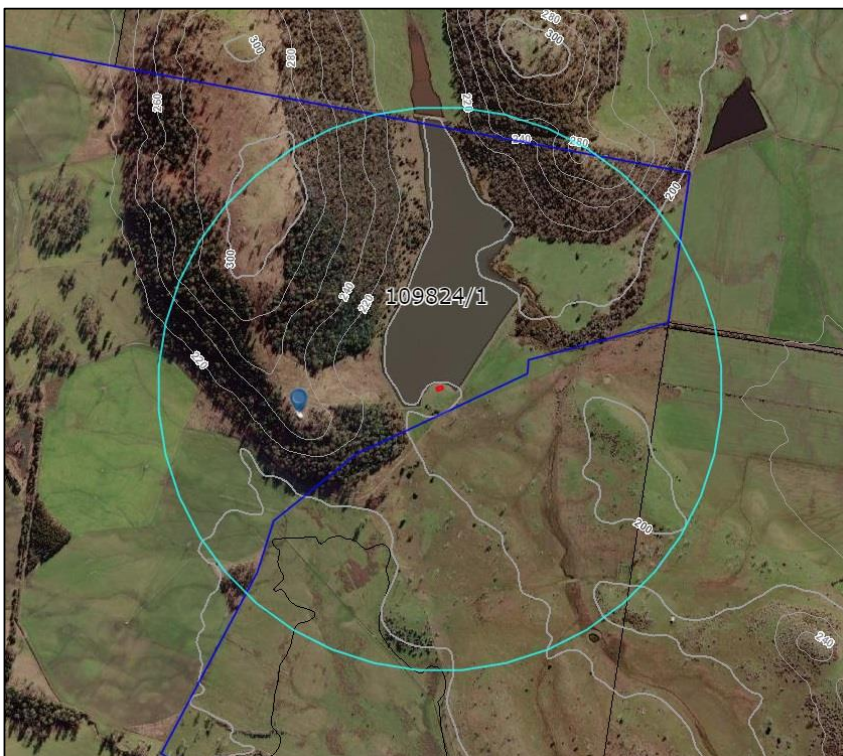
Figure 11. No neighbouring dwellings apart from manager's residence (blue pin) at subject property within 1km (light blue circle) of proposed visitor accommodation (red area) (Source: The LISTMap).

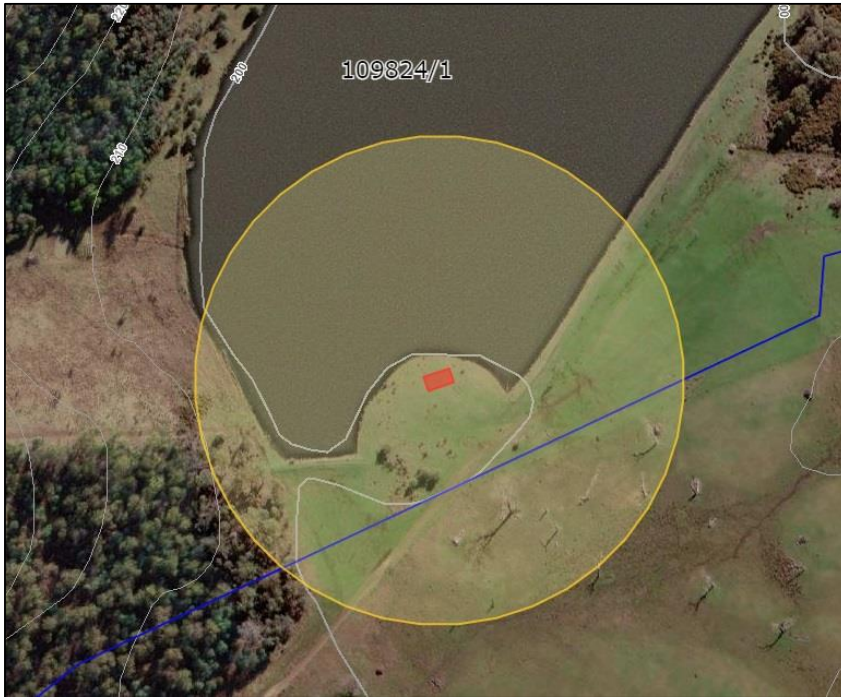
Figure 12. No neighbouring dwellings within 200m (yellow circle) of proposed visitor accommodation (red area) at the property (Source: The LISTMap).

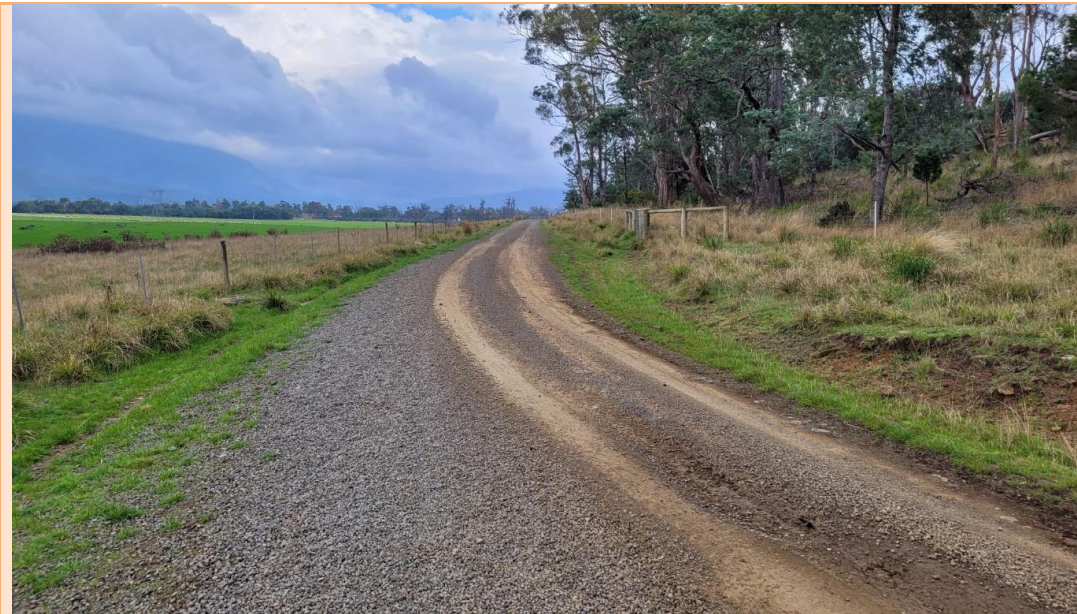
Existing access (3.5m wide approx.)

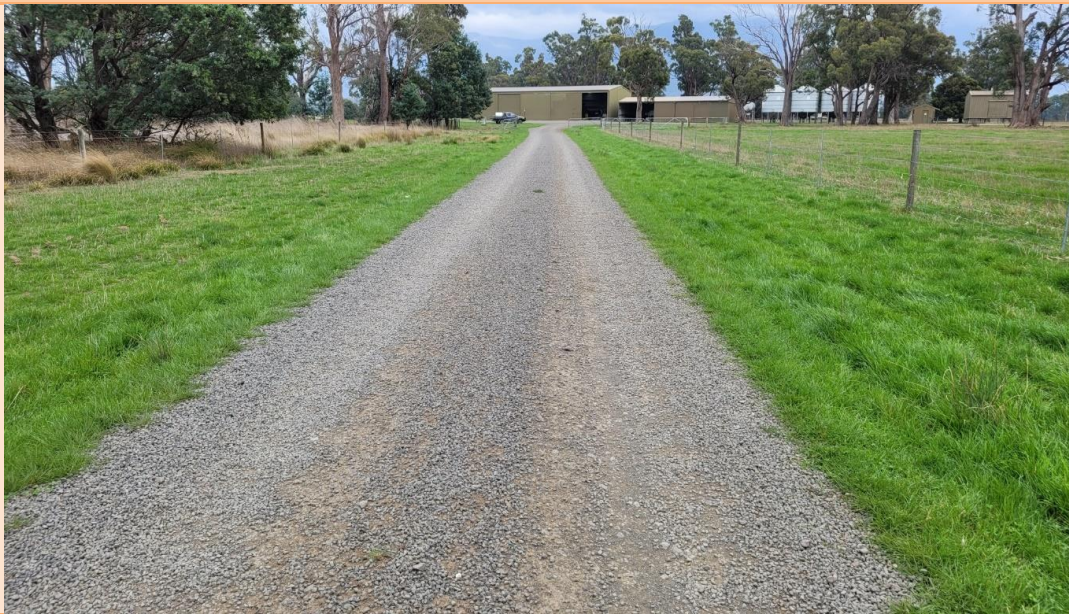
Existing driveway (3.2m wide approx.)

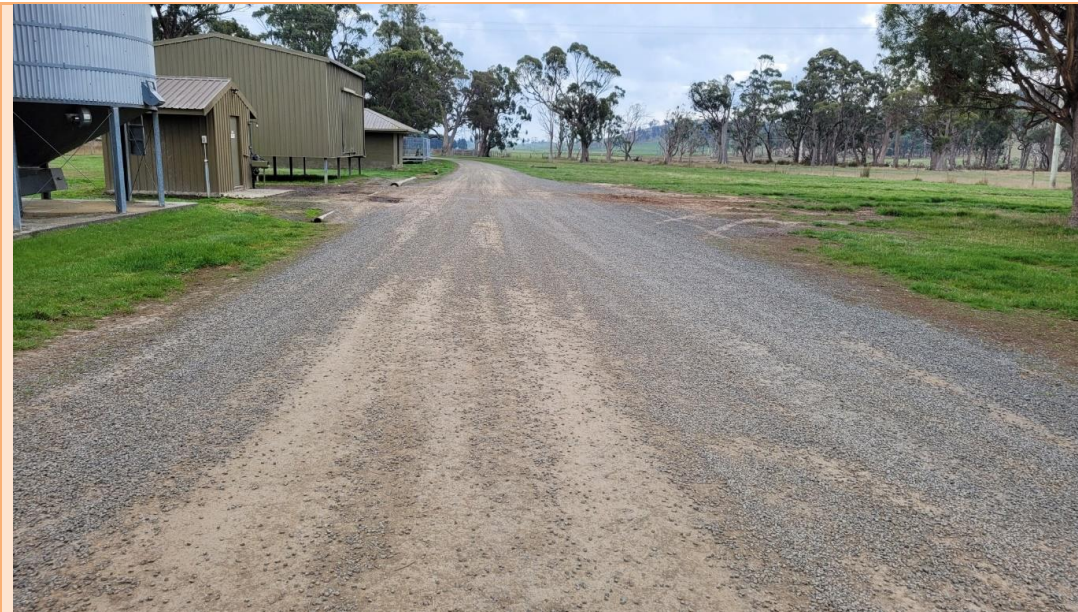
Existing driveway (6.3m wide approx.)

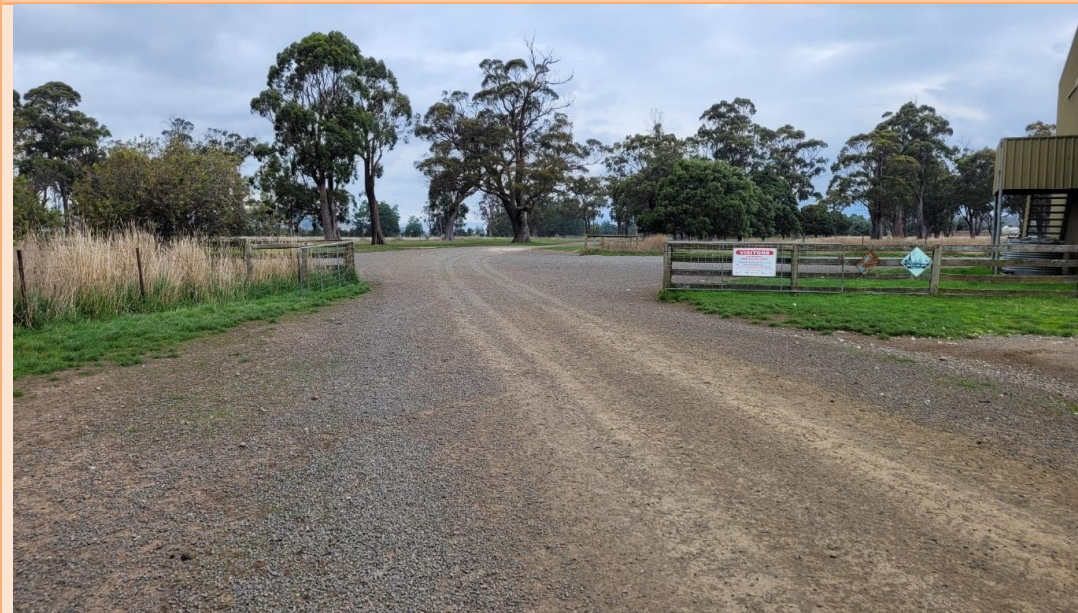
Existing driveway (6.0m wide approx.)

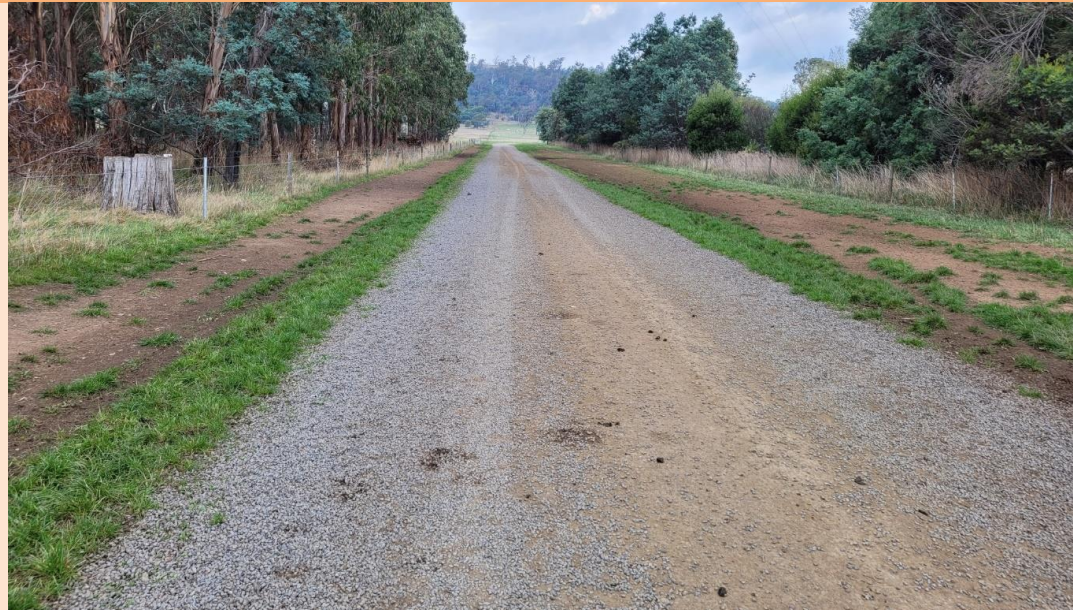
Existing driveway (4.6m wide approx.)

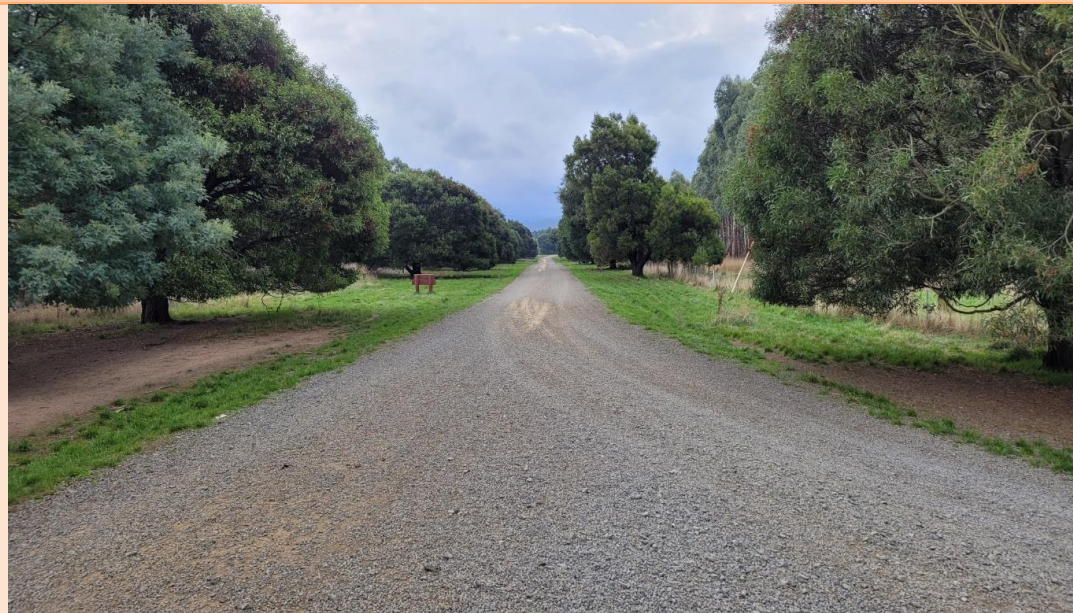
Existing driveway (4.5m wide approx.)

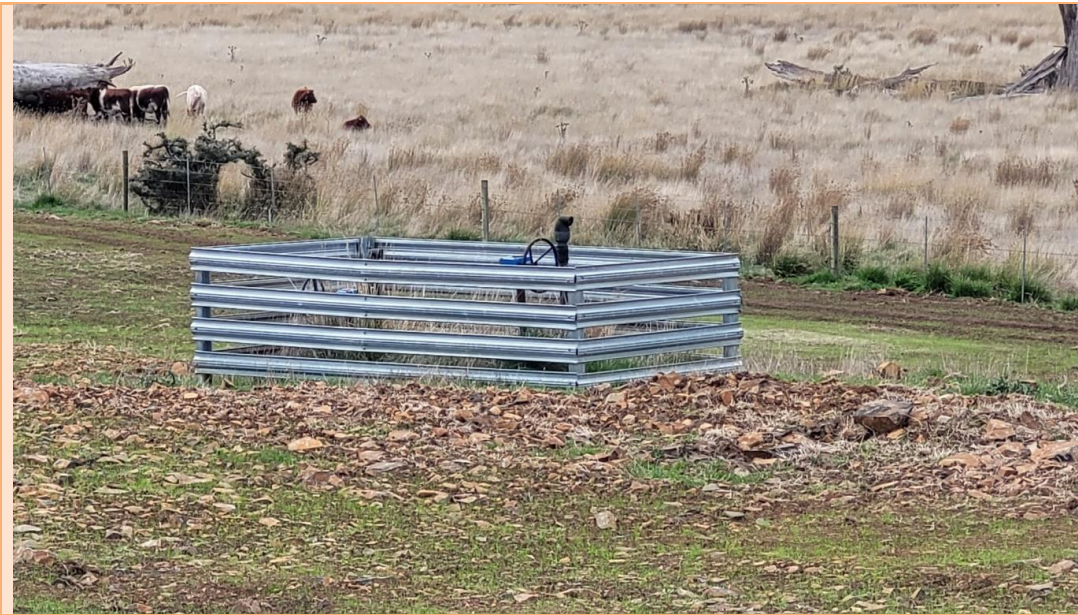
Location of proposed water connection point from existing static supply of dam
