7.6 Codes

2225 - Palmerston BESS

Aboriginal Heritage Assessment Report
Final Version 1

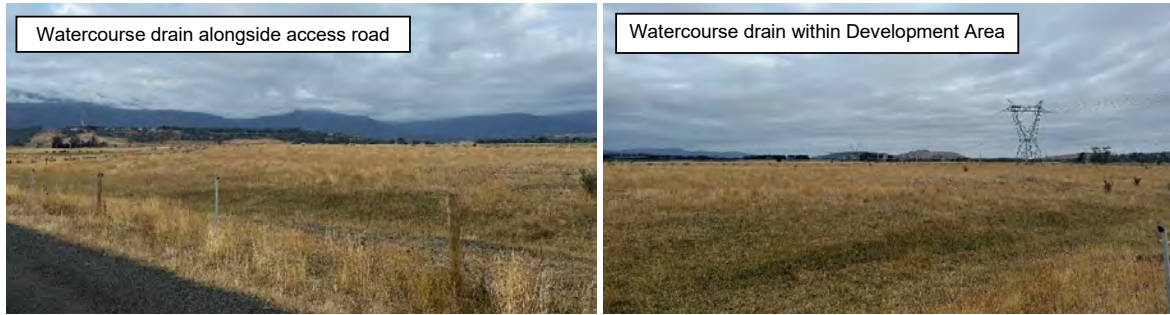
The minor-tributary crosses through the southern BESS area, while the joined tributary is a formed drain within the substation land, that the proposed 33 kV underground transmission line will cross. Photos of both watercourses are shown in the following photos.

As the photos demonstrate, the waterways have no defined bed and bank and appear as minor grassed drainage lines in the landscape, and in some parts are not discernible. Some earthworks will be required to realign these drains which also offers the opportunity for improvements and naturalisation. Considering the minor nature of the tributary, the Proposal is considered acceptable against the provisions of the Natural Assets Code.

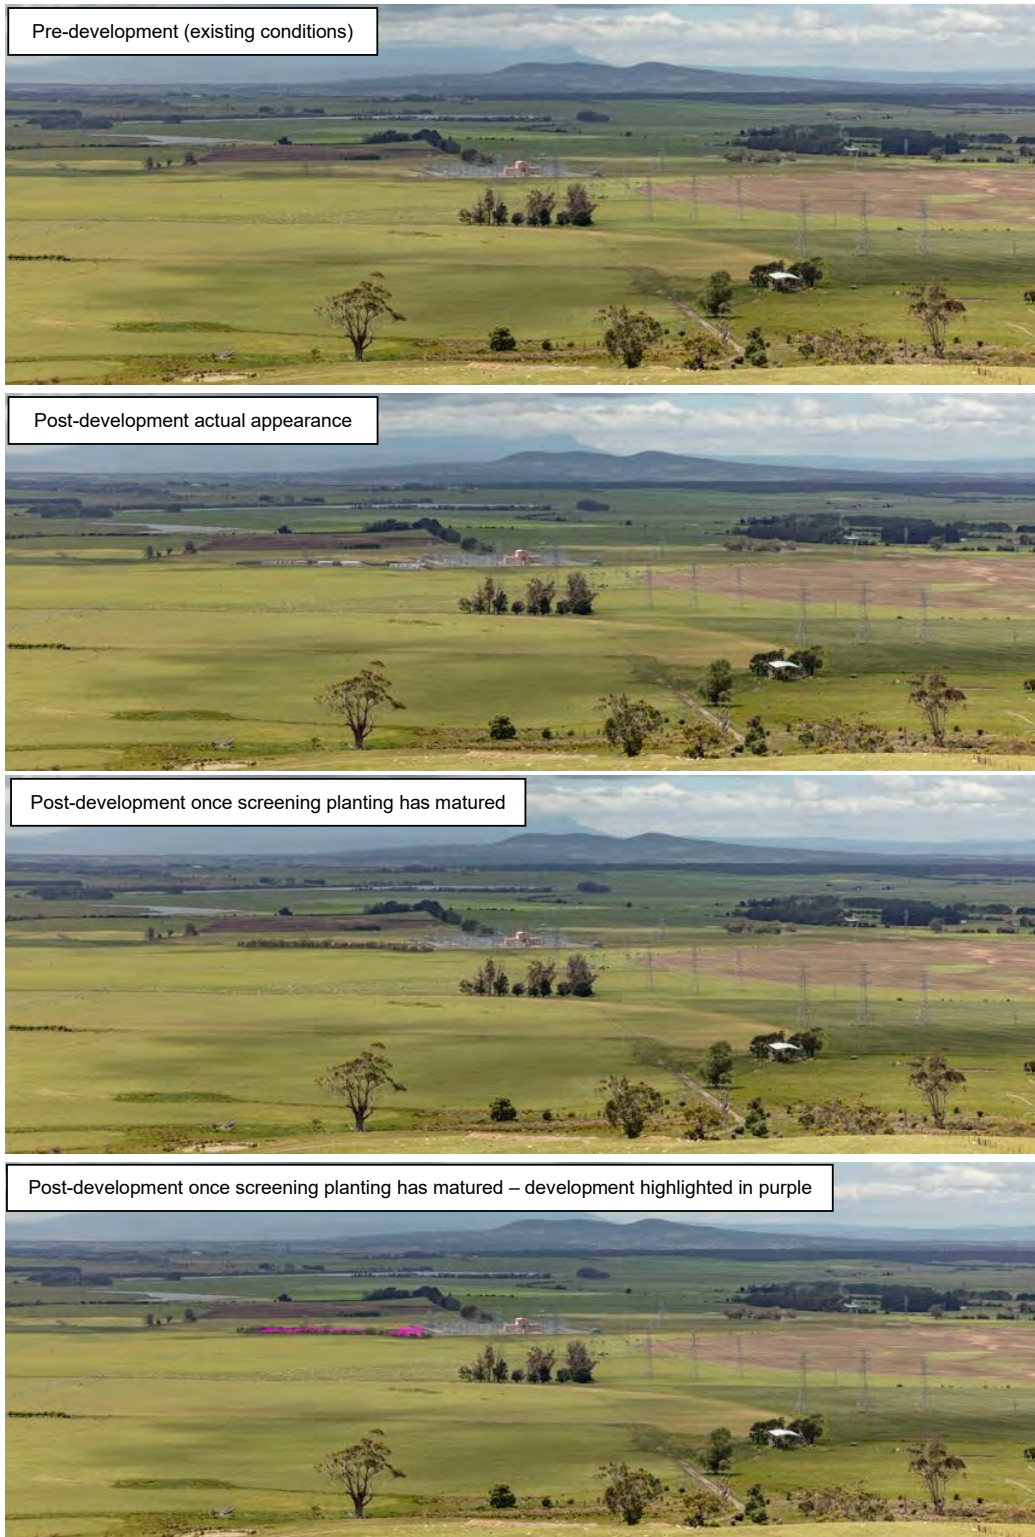
Figure 13 Photomontages from viewpoint: pre and post-maturation of vegetation screen planting

The assessment concludes that the Proposal and existing terminal station, with their similar use and physical characteristics can visually integrate harmoniously into the existing environment without significant impacts. Existing vegetation and planned screening measures effectively mitigate potential impacts upon views from nearby dwellings and roads.

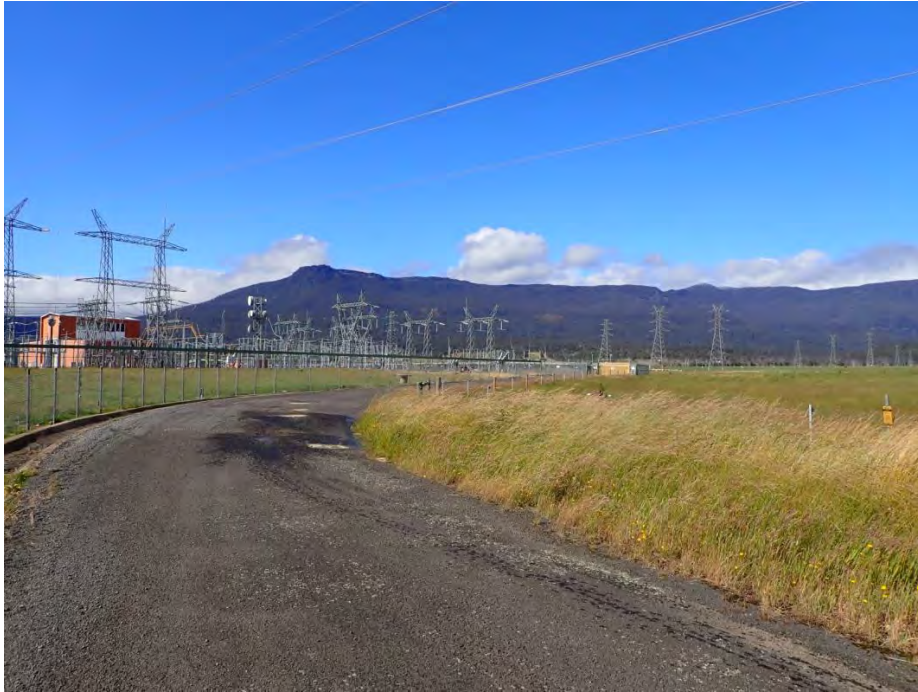
Plate 5: View southwest showing the graded access track in the study area.

The entire study area has been intensively disturbed. The entire study area and immediate surroundings have been subject to past clearing to make way for agricultural activity. The main access track leading into the study area has been graded with bitumen to facilitate access to the Palmerston Substation which is immediately adjacent to the eastern border of the study area (see Plate 5). The construction and ongoing maintenance and development of the Palmerston Substation have also been a source of disturbance to the study area. Any Aboriginal sites that may be present within these more highly disturbed infrastructure/agricultural areas will have been either destroyed or heavily impacted.

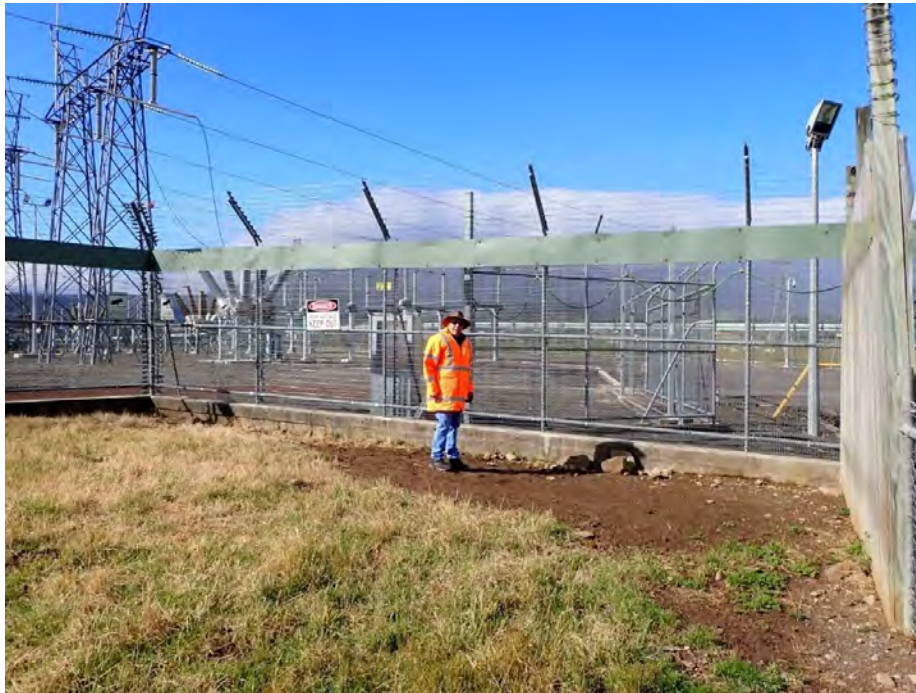
Plate 6: View south showing an erosion scald within the study area that provided 100% surface visibility.

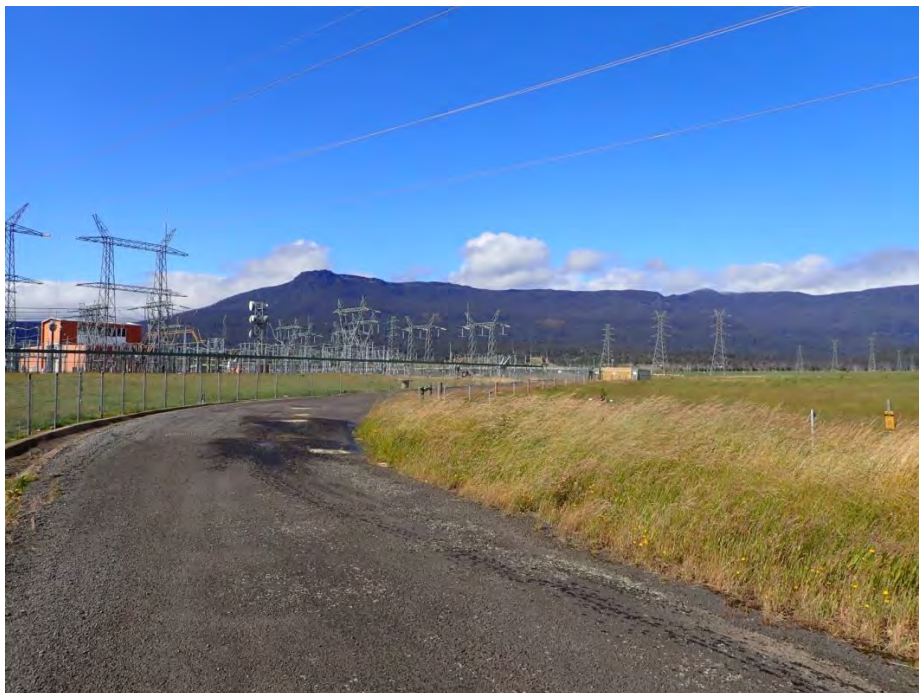
Plate 8: View southwest showing the graded access track where surface visibility dropped to <10%.

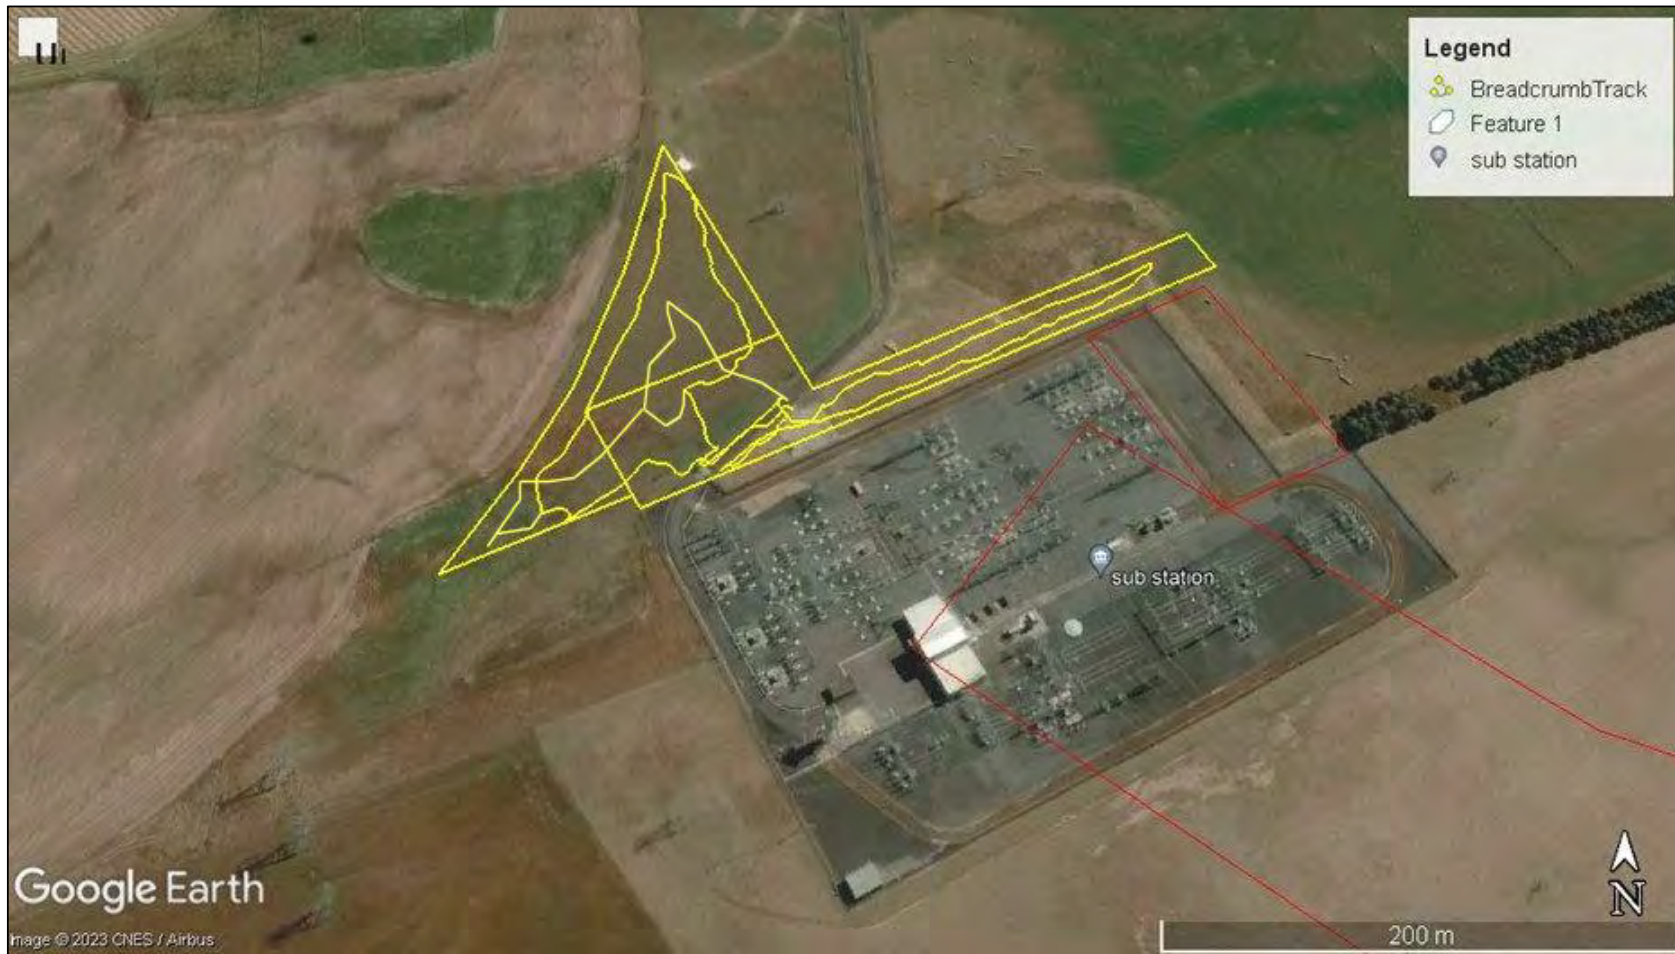
Figure 9: Aerial image showing survey transects walked by the field team across the study area.

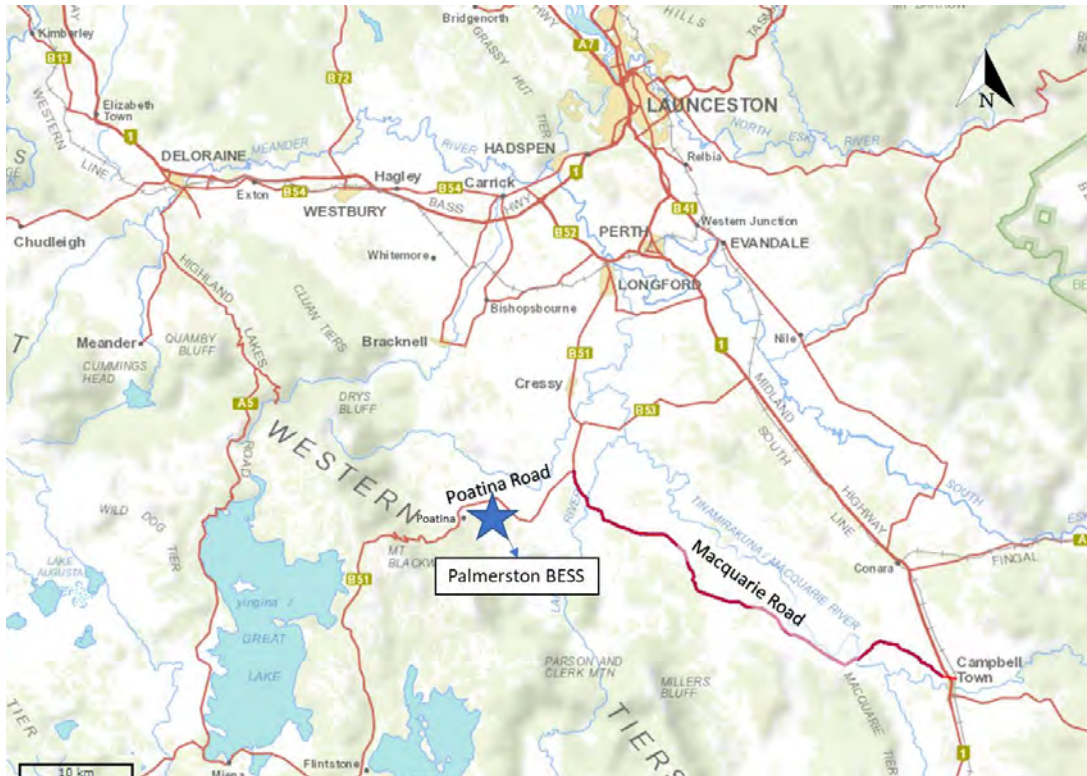
Figure 1: Palmerston BESS Site Location

The development footprint for the Palmerston BESS covers 1.5Ha adjacent to the existing Palmerston Substation located approximately 2.3km east of Poatina (see Figure 1, below).

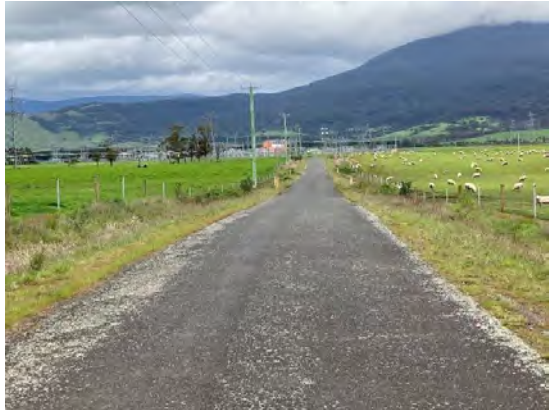
Figure 5: Palmerston Substation Access Road (looking south)

Palmerston Substation Access Road has an average width of 4.5m. It operates as a circuit around the substation, ensuring vehicles enter and exit the site in a forward direction.

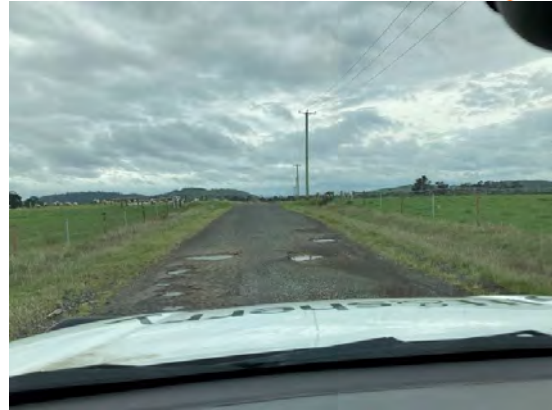
Figure 6: poor state of repair of Palmerston Substation Access Road

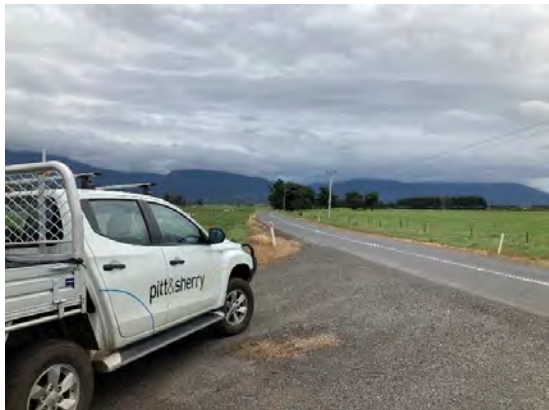
Figure 7: Poatina Rd, west approach to Palmerston Substation Access Rd

The Safe Intersection Sight Distance (SISD) has been assessed for the proposed site access in accordance with the *Austrroads Guide to Road Design – Part 4A: Unsignalised and Signalised Intersections*. The speed limits on Poatina Road are 100km/h resulting in a required sight distance of 248m. The sight distances observed on site (Figure 7 and Figure 8) meet the required SISD of 248m in both directions (see Table 2, below).

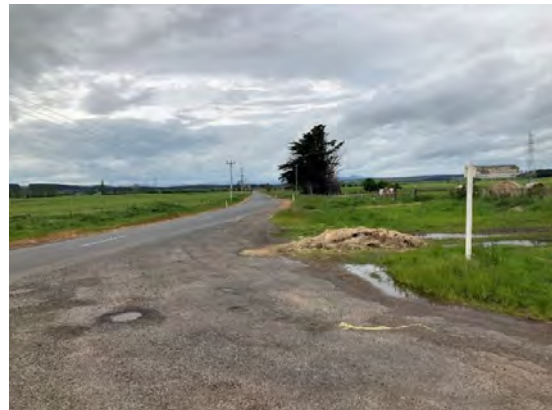
Figure 8: Poatina Rd, east approach to Palmerston Substation Access Rd
