### PALMERSTON BESS (Battery Energy Storage System)

**Report Name:** Fire Hazard and Risk Assessment

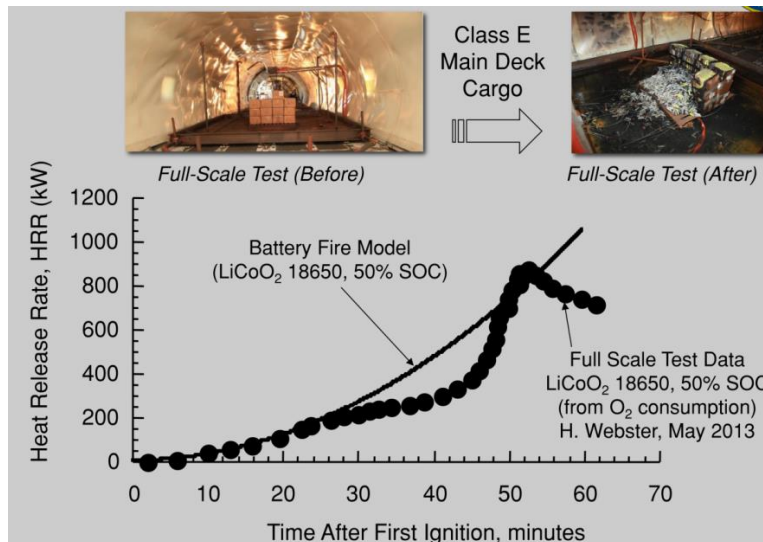
Figure 14: Results of full-scale tests on 18650 batteries

The peak heat release rate is approximately 1MW.

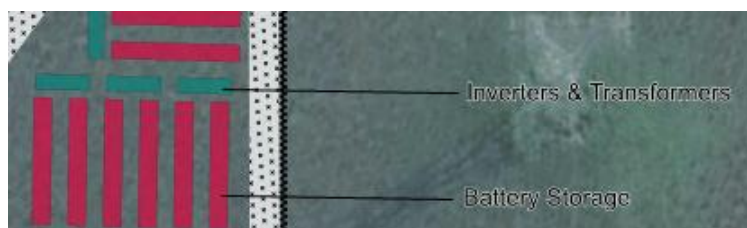
**Figure 32: Inverter and transformers**

The subject facility will have insulated transformers with less combustible liquids and enhanced protection. The subject facility will have small transformers that will be located at the end of each row of battery storage units (shown in figure below and Appendix A).

It is understood that the transformers’ specification specifies FR3 (or similar) Ester oil in lieu of the normal mineral oil. This oil would have a flash point of approximately 330°C compared to 145°C for standard oil and hence is less likely to result in a fire.

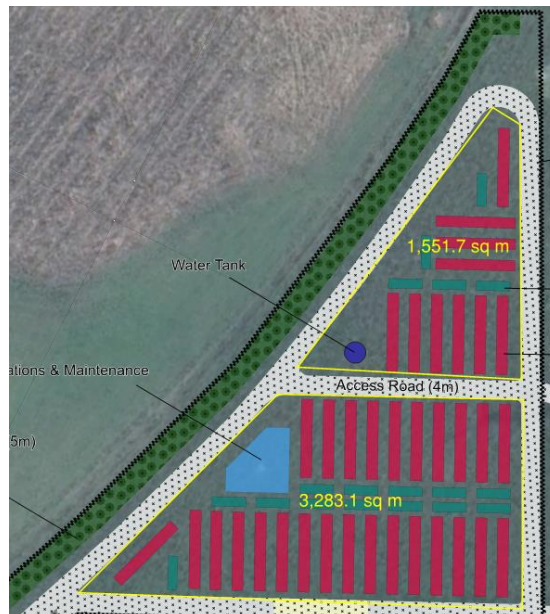
**Figure 33: Arrays of battery Storage units.**

The facility is approximately 11,200m<sup>2</sup> within the security fence. Two battery arrays are separated from each other not less than 6.0m apart and each group of battery array is approximately not more than 3,300m<sup>2</sup> (Figure 32). Accordingly, 2 hydrants running are required by the standard.
